A Preliminary Investigation of the Archaeology and History of Philipshill Mill, Wester Kittochside, Scotland

A Report by Sean Winter, on behalf of the National Trust of Scotland

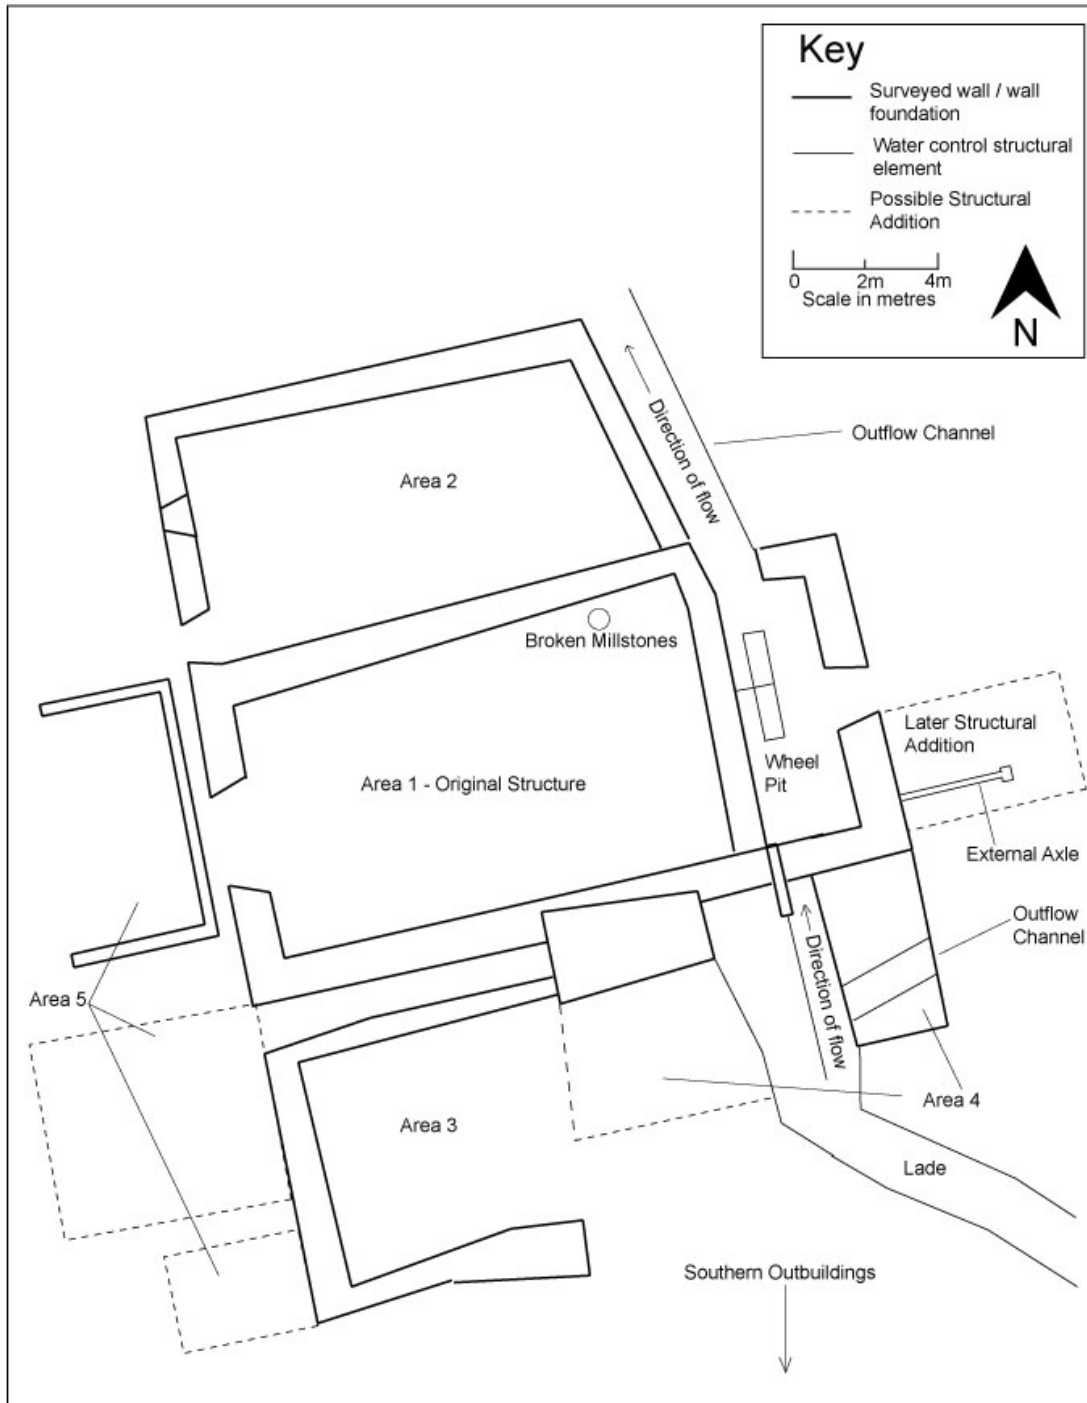
Appendix One - Plan of Philipshill Mill from archaeological work carried out in May 2007

This data was then combined with other archaeological data to develop a very detailed plan of the site (see Figure 1, in Appendix One). Extensive vegetation coverage limited some aspects of the EDM survey and data collection in some parts of the site was extremely difficult.

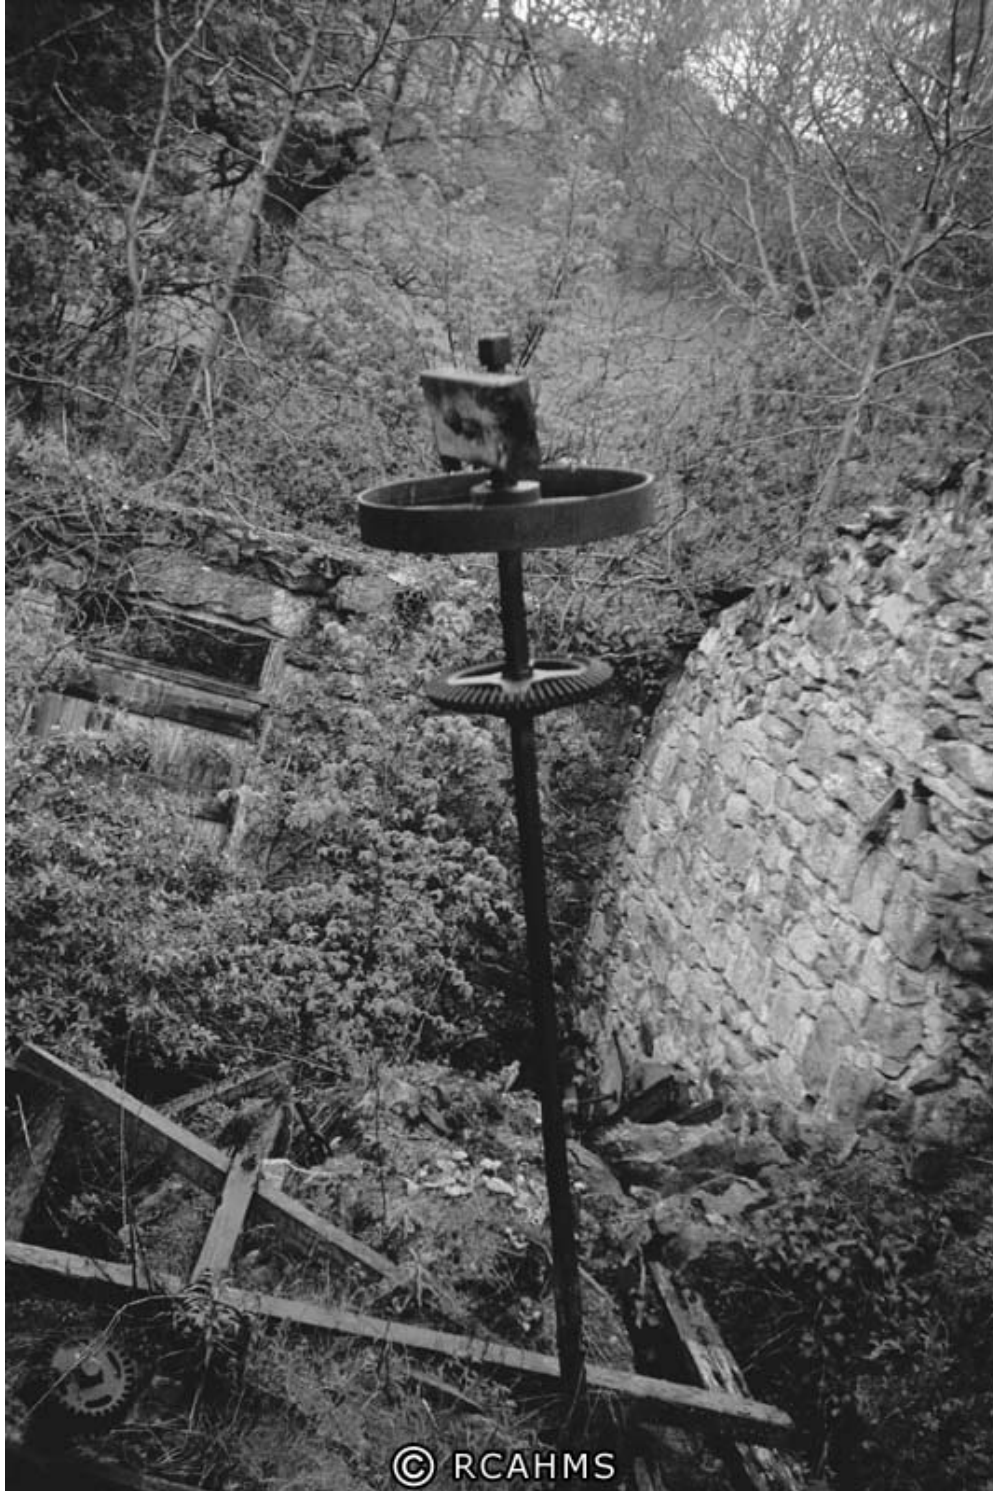
Figure Ten: Photo of the mill engine c. 1965 (after Hume 1965)

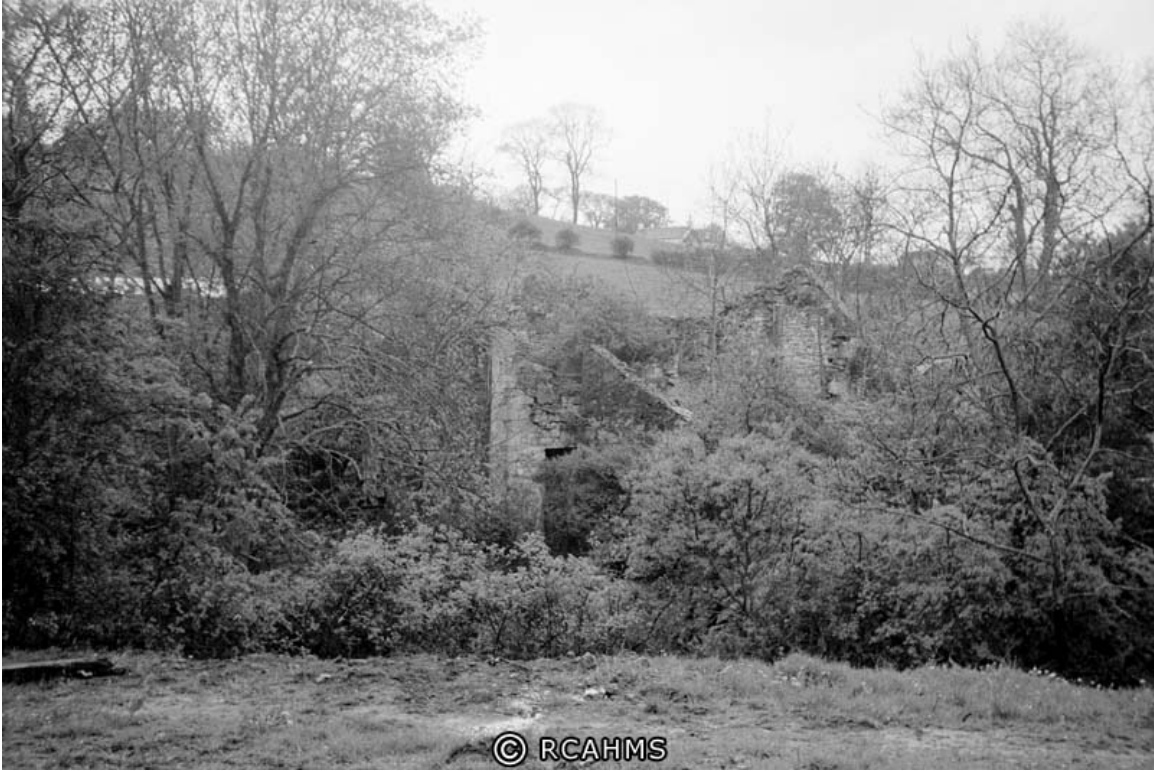
Figure Eleven: Photo of the ruins of the mill c. 1965 (after Hume 1965)

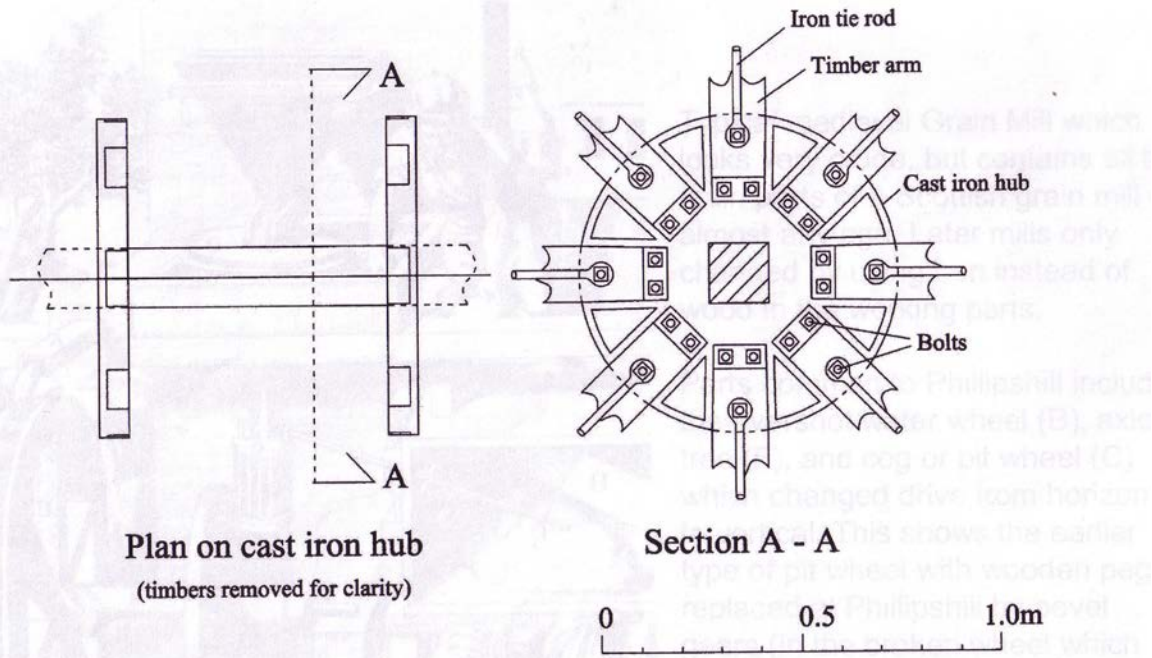
Details of surviving Water Wheel hub
 Philipshill Mill (East Kilbride Parish)

Nisbet recorded the remains of the wheel (see Figure 18, Appendix Four) concluding that its dimensions "...exceeded 6m diameter by 0.8m wide, giving efficient use of large fall on relatively minor watercourse" (2003: 1). Nisbet also suggested that the wheel may have originally been smaller and sited outside the building, before being moved inside. This current investigation did not disprove the theory that there was a wheel situated outside the building. However any external wheel would probably have been in addition to the internal wheel, as the structural remains relating to the wheel are of the same character as those in the extant section of Area 1, suggesting it was sited and built internally as an original design feature of the mill. Investigation of the structural nature of the wheel pit showed the wall between the gear and wheel pits to be structurally very similar to the external walls of area, with the same monolithic masonry, mortar and importantly, wall thickness. As each new addition to the mill displayed differences in these areas it is not unrealistic to thus interpret the wheel as having always been located internally.
