Fallgate Mill

Ruth and Keith Andrews

Fallgate Mill and the Clay Cross Company

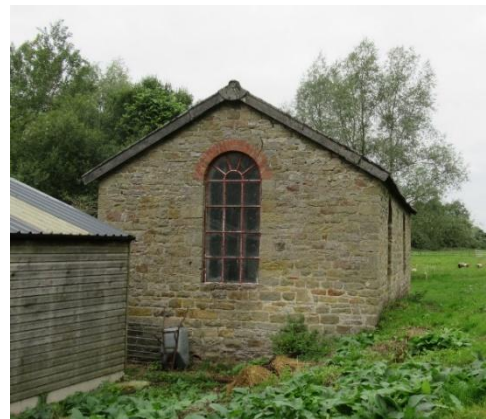
The power house, built with materials from demolished buildings on the same site, with large cast iron windows.

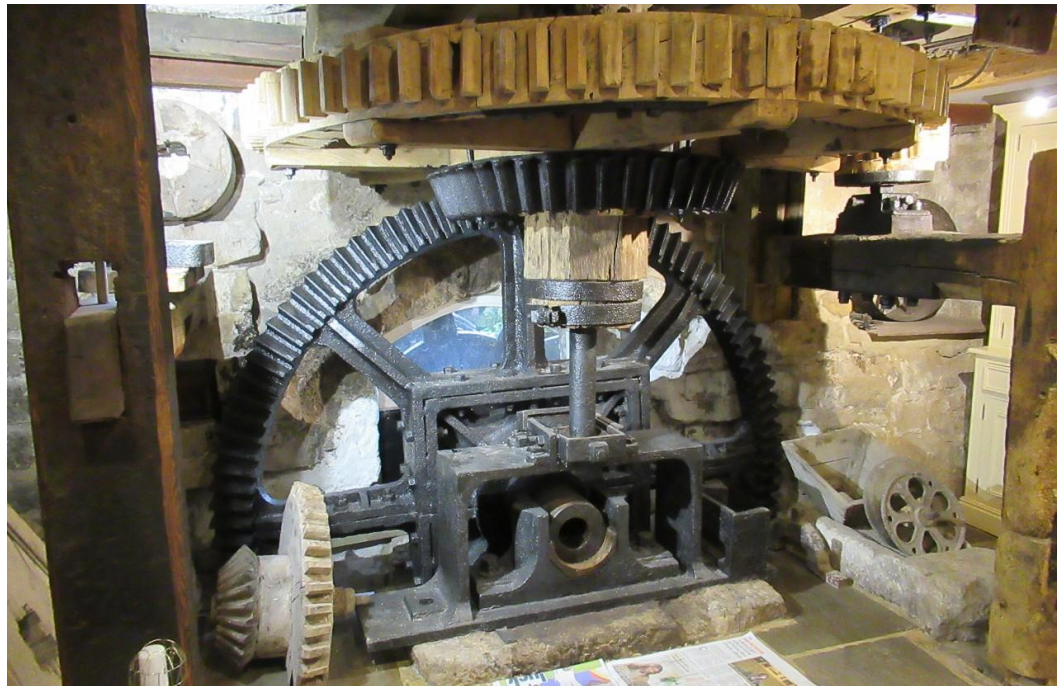
(Above) Details of wear on the teeth of the great spur wheel and wallower

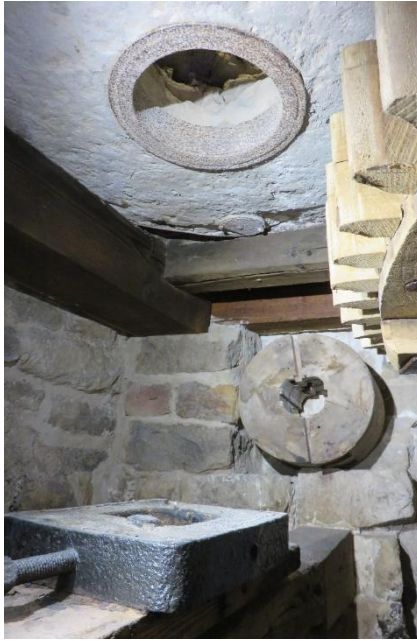
(Above left) At first glance, this is a bedstone, but it is actually an upside down runner stone, which at present is letting a cold draught into the living room upstairs.

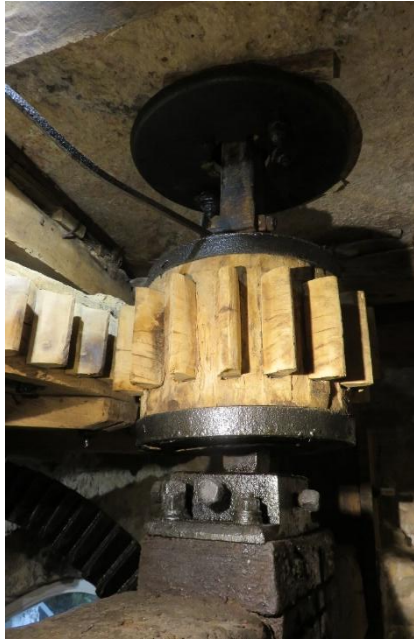
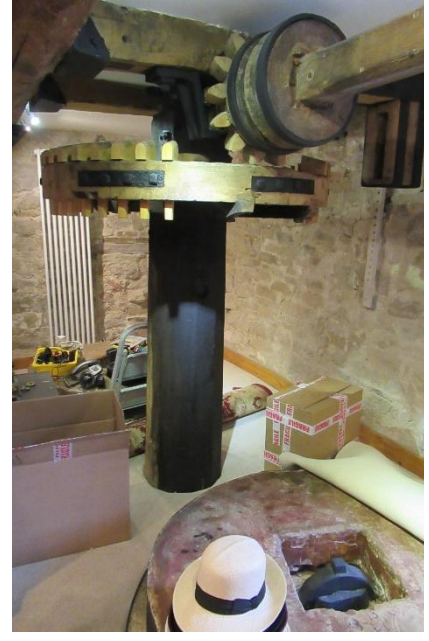
(Centre and right) The restored stone spindle looks OK, but the stones above it are clearly not a matching pair. Also the layshaft and the crown wheel have been heavily 'restored' and fossilised by being cemented into the wall.

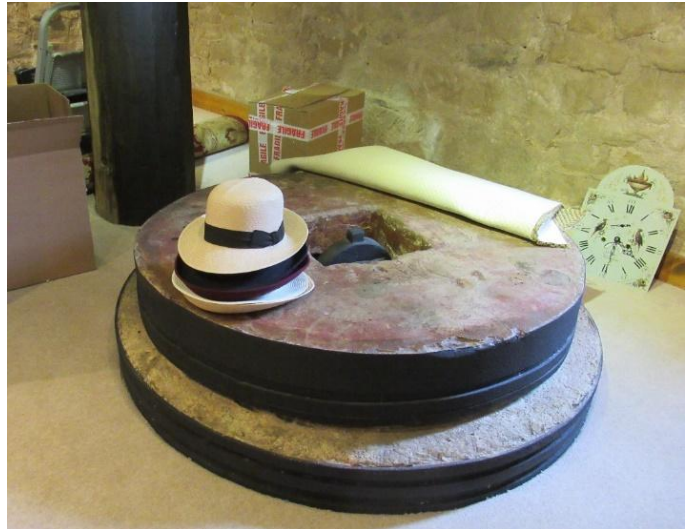
So much restoration work has been carried out a various times that it is hard to see what the stones were like when they were in use.

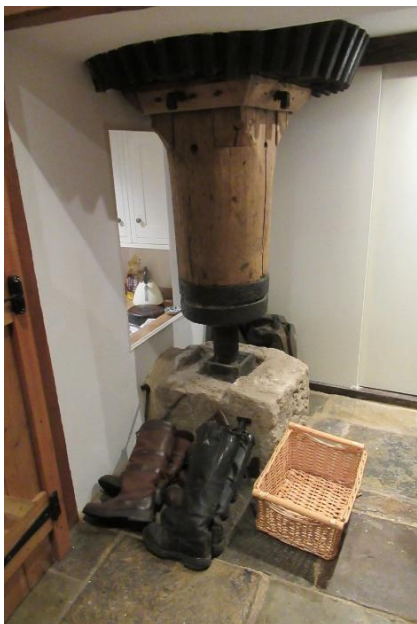
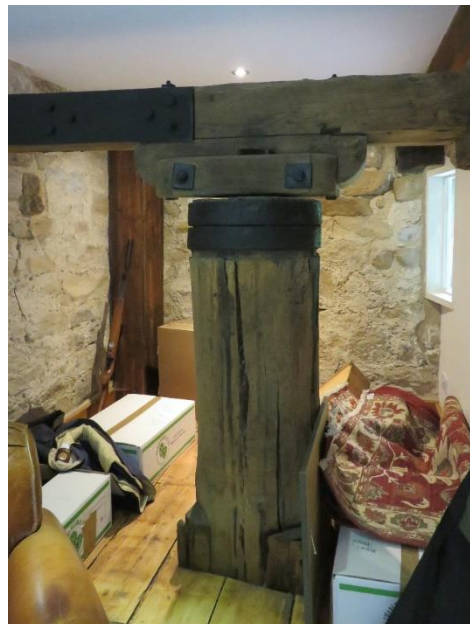
At the other end of the building the missing waterwheel drove an upright shaft, which is still in place along with its wallower. This is the only part of the machinery remaining on that side of the mill.

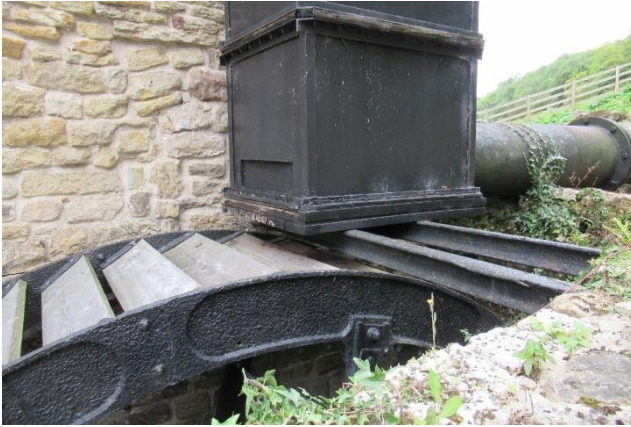
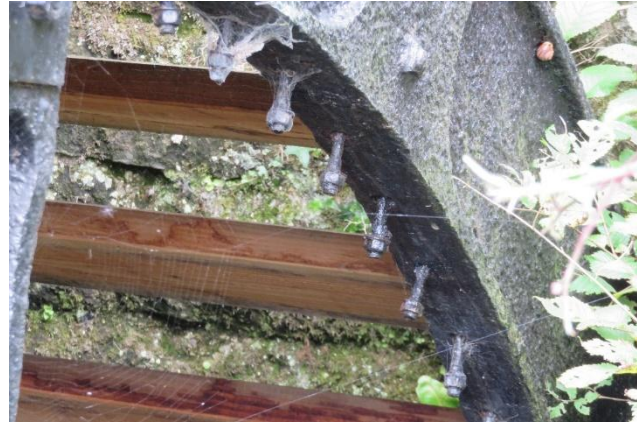
The cosmetically restored waterwheel needs some remedial work. At present the penstock is not attached to either its supports (which appear to be railway track) or the building, and has a lot of wood in its construction. Also, the new wooden bucket boards are too short, and the sole plate is completely missing, although its bolts are clearly visible.

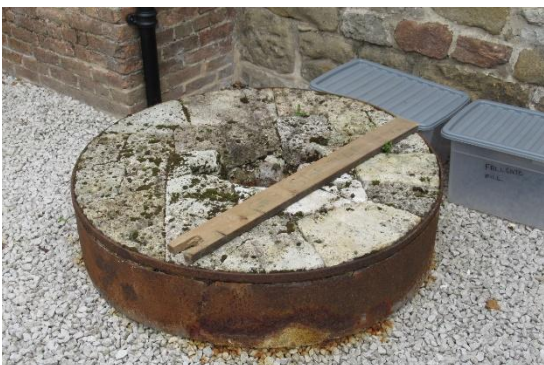
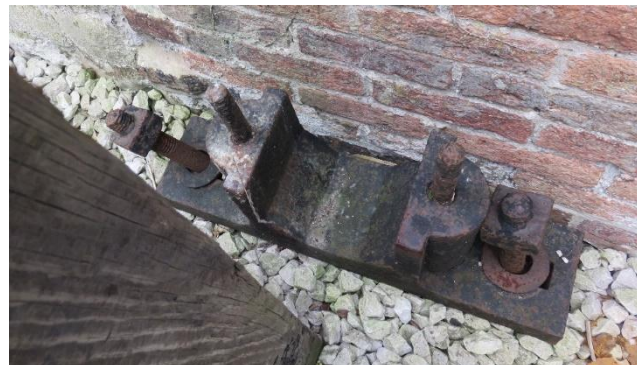
There are various other interesting artefacts around like this wire machine, which is on the site of the other wheel pit (note the axle hole); also outside are a number of millstones and part of an axle bearing.
