## Hockley Mill Sluice Rebuild

**Ivor New and Mick Edgeworth**

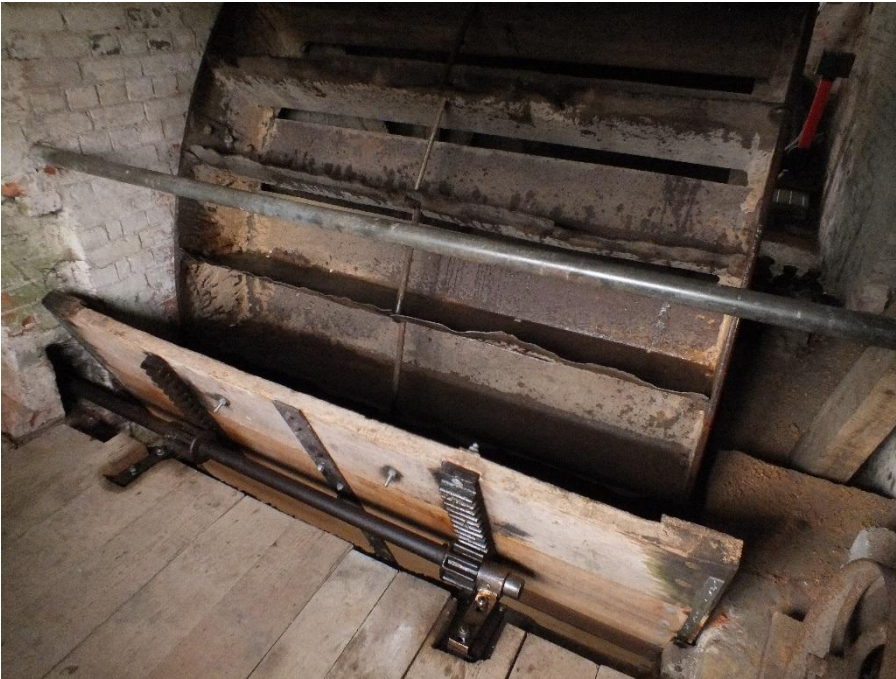
The finished sluice

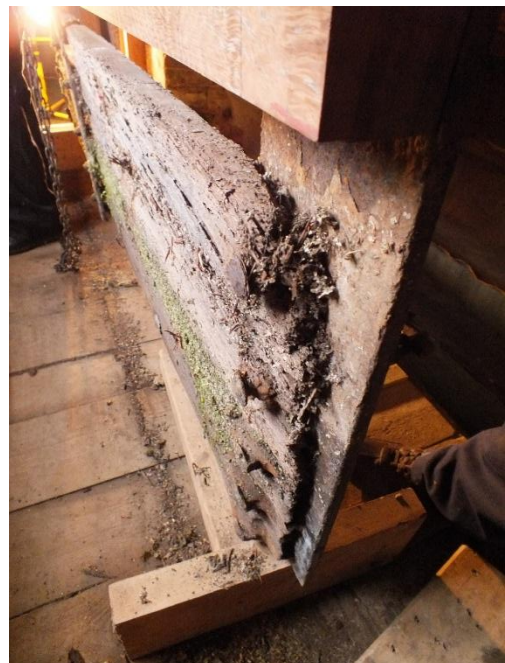
Some months ago one of HMG's members Ivor New was persuaded to undertake a design study and repair the sluice. Essentially the brief was to provide a sluice that had a long working life with low maintenance requirements, all at minimal cost. There was no restriction on materials used as long as the existing control arrangement was retained and there were no constraints on returning it to the original design and materials. A detailed examination of the sluice showed that it was in far worse repair than expected and would require a complete rebuild (*as shown on the right*).

All the boards of the sluice, apart from the top board, which was well above flood level, needed replacement. The good news was that the sluice operating gear and iron work was in relatively good condition and reusable.

The first phase of the project was a design study to determine the materials and repair strategy to be used. The decision was made to use iroko for the sluice boarding with galvanised fittings and fixings, the reasoning being given in an appendix below. The required materials were purchased and the project implementation started on site where the work progressed smoothly, if a little slowly. The iroko boards were supplied cut accurately to length, thickness and combined overall width. To improve the long term performance of the sluice it was decided to incorporate a seal between the boards. To achieve this rebates were cut down the mating surfaces of the boards to house strips of self-expanding weatherproof foam.

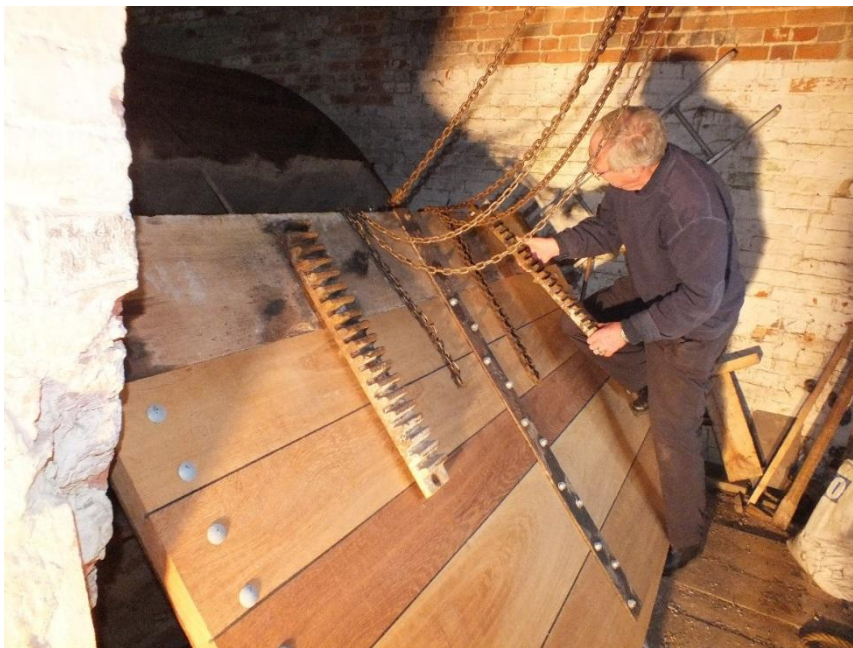
Ivor replacing a rack.  
Notice the original top board and the central iron strapping.  
The new sluice is about to be hauled into position for the first time.

The final task of replacing the racks for the operating mechanism was much simplified by the retention of the top board which provided the basic location references.
