Durngate Sluices, Winchester

Ruth Andrews

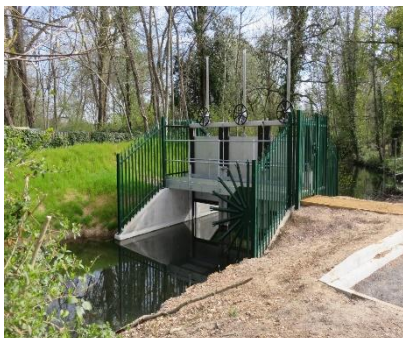
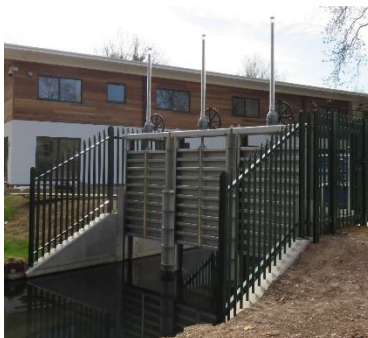
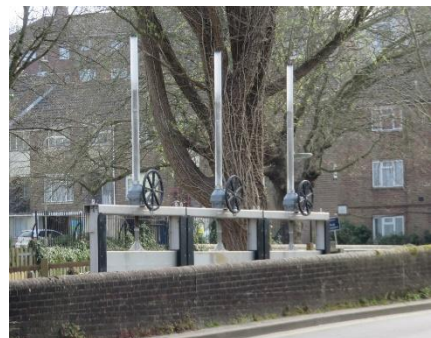
New sluices left to right 1, 2, 3

Two of the gates are located either side of Durngate car park (*1 and 2 on the map*) with the third (3) between the road and pedestrian bridge at the entrance to Winnall Moors. So if they are closed because of rising water levels, Winnall Moors NNR will be inundated.

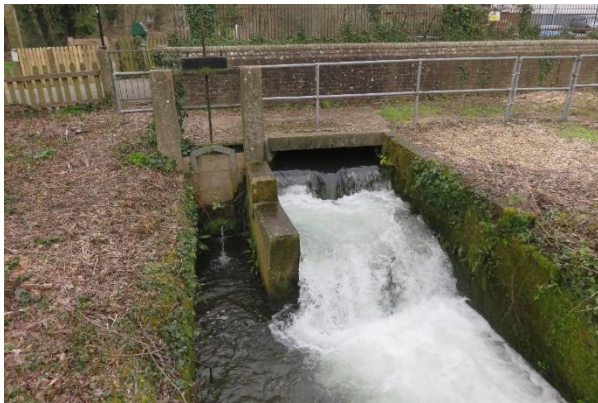
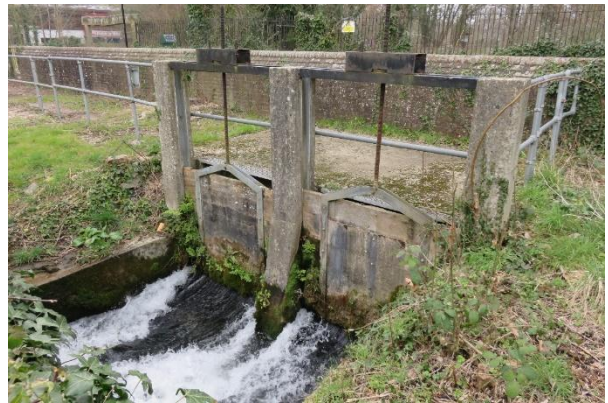
Dungate Mill sluices A and B

Unfortunately the existing sluices at the Durngate Mill site, a single sluice (A) and a double sluice (B) across the divided main river flow, have not been replaced and look to be in poor condition.

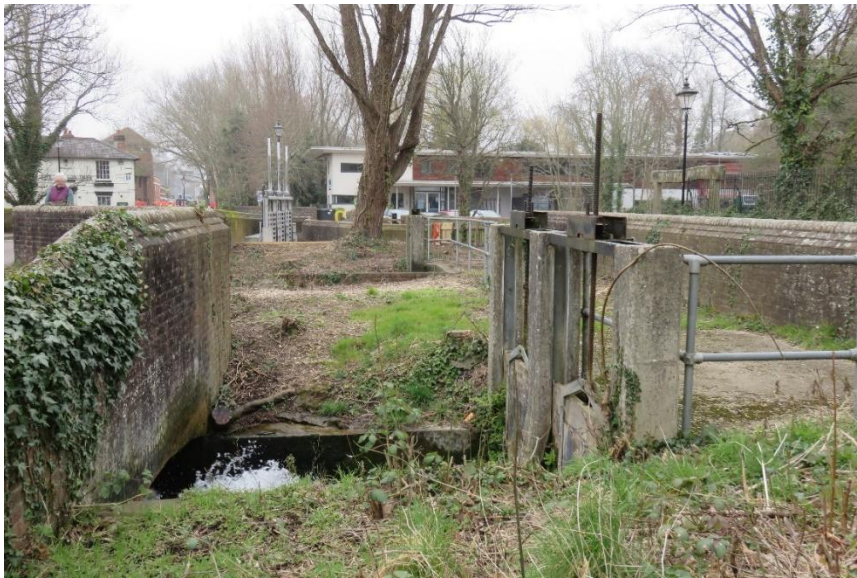
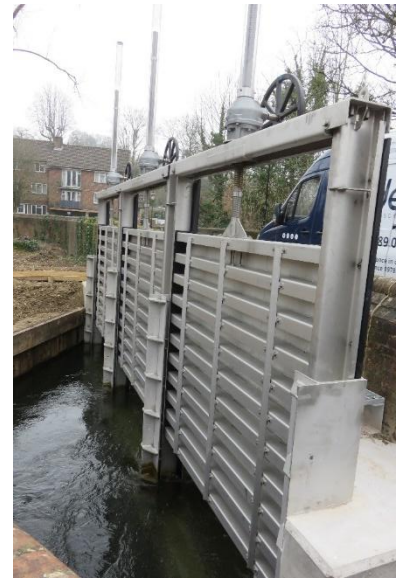
Site of Durngate Mill showing old sluices (foreground) and new sluice 3 in the distance and right
