Broughton Manor Farm Staddle barn and attached Watermill

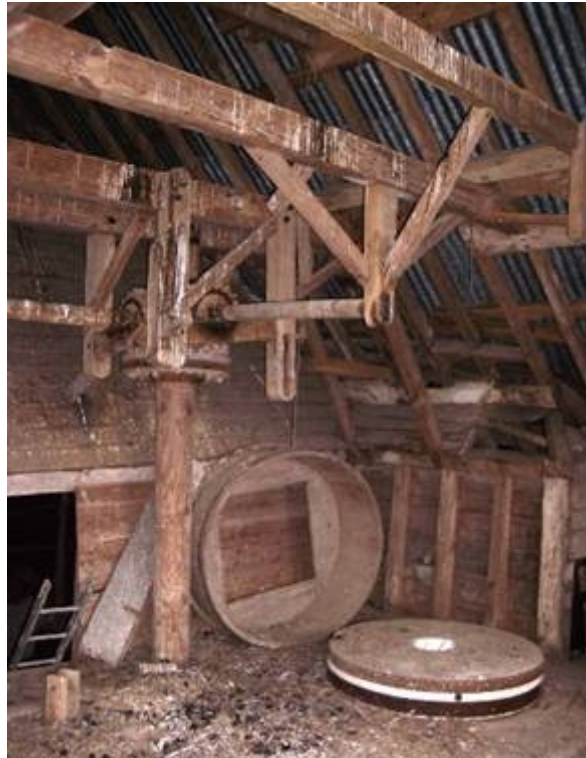
A LOT OF CLEANING TO DO ON THE MILLSTONE FLOOR

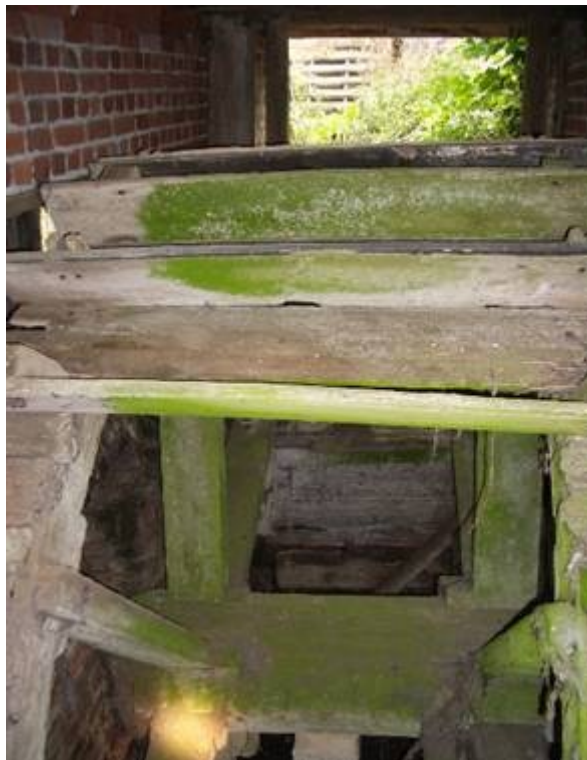
The internal waterwheel had a mid-breast feed. It is all-wood and of compass arm construction; the axle, arm and felloes remain complete and over half of its floats are still in situ.

THE COMPASS-ARM WATERWHEEL IN NEED OF A LITTLE TLC

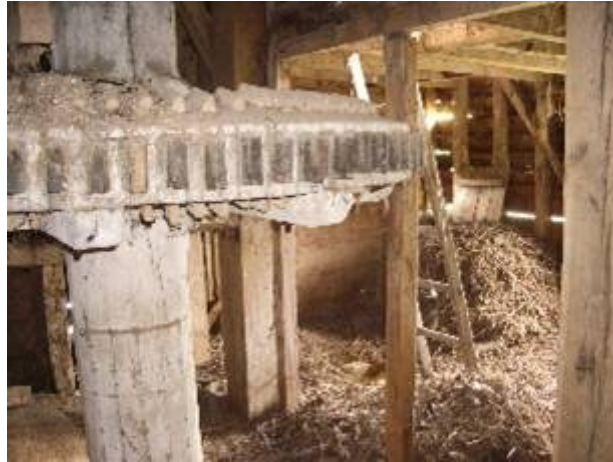
DEEP CLEAN NEEDED

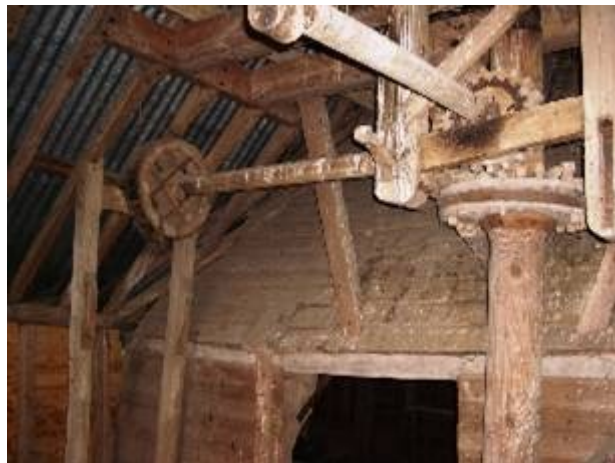
TOP OF SECONDARY UPRIGHT SHAFT SHOWING HORIZONTAL SHAFTS

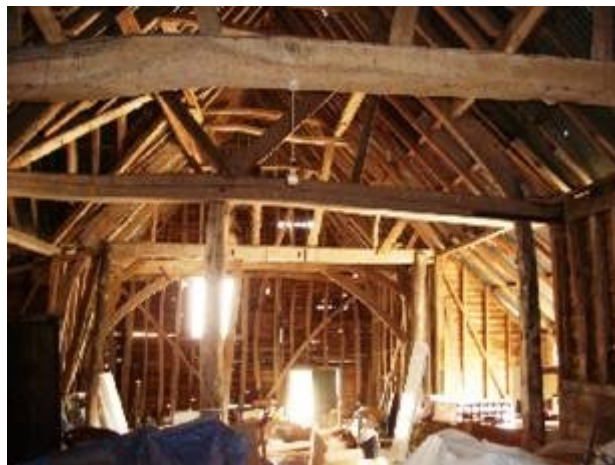
STRIKE A LIGHT LOOK AT THE ROOF

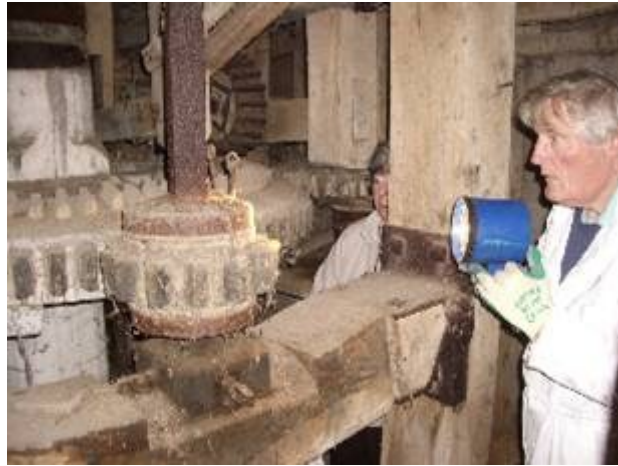
YOU GO FIRST WITH THE COBWEBS ANGELA
