Irton Manor Watermill – history, excavation and conservation

David Fortune

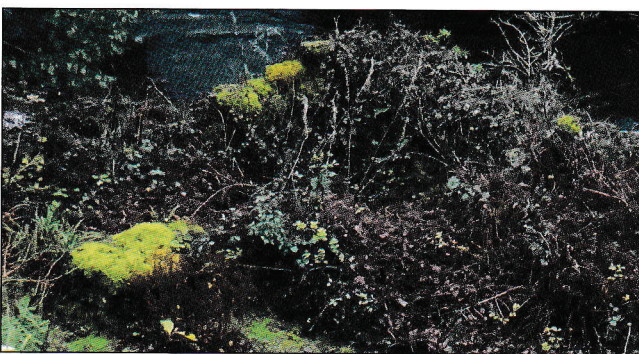
Fig. 1. In 2017 the ruins were further dilapidated and extensively overgrown.

In 2017 the watermill, mill race and leat remains were completely masked by dense weeds, brambles, trees and shrubs. Since Mike Davies-Shiel's photograph of 1968 more stones have fallen from the riverside wall reducing its height to 10-12 ft. Furthermore, the landside walls were pulled

down to enable even more building and landscaping rubble to be barrowed and thrown into the mill ruins.

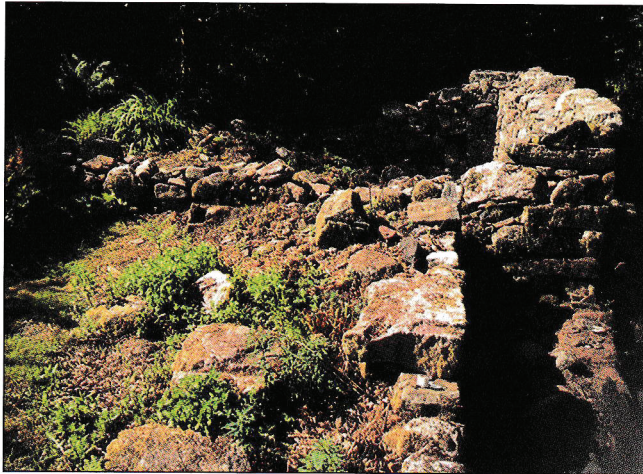
Fig. 2. Excavation began in 2019. Bedding of walls with clay soil and lime-rich mortar pointing had been mostly washed away. View of mill from mill race.

The mill was constructed of granite, limestone, basalt and andesite from local quarries and the riverbed, mortared with clay soil and lime-rich mortar pointing. It appears to have had a pitched roof with thick slate tiles. Stones had fallen and some removed, with partial collapse of the head and tail race areas and the riverside wall. Boulders supported the walls within and outside the mill.

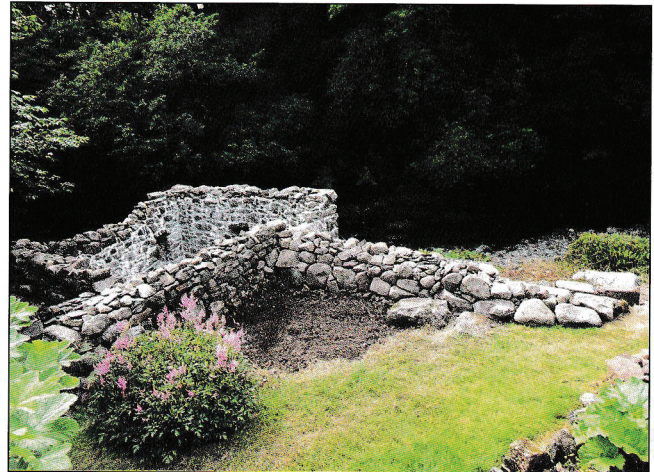
Fig. 3. By mid-2021 the mill was fully cleared, stabilised and lime mortar pointed where required.

The hidden remains of Lords Mill were revealed and stabilised by the owner over two years during dry summer weather, using a trowel, buckets, a block and tackle, a ton of hot lime mortar, several short rebars and 100kg of limestone chippings.

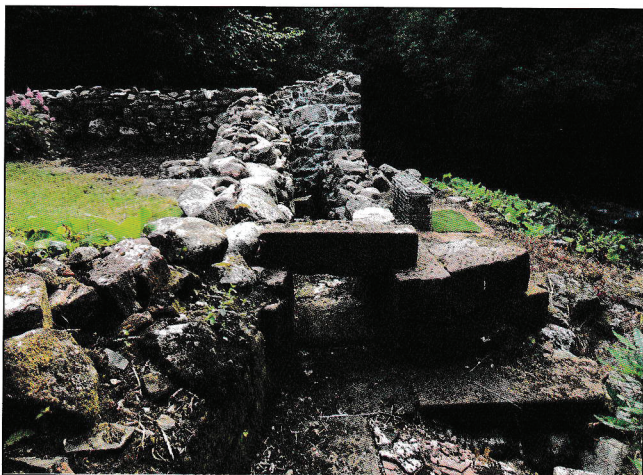
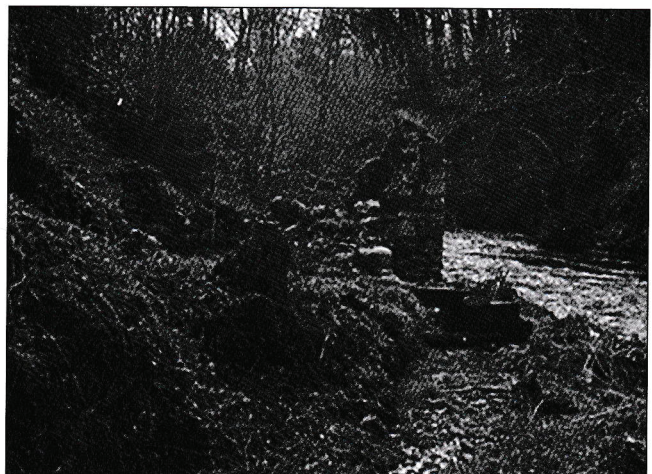
Figs. 4 and 5. The photograph on the left, looking from the mill race to the mill, was taken in 2021 and can be compared to that on the right, taken by Mike Davies-Shiel in 1968 (reproduced with kind permission of the Cumbria Industrial History Society).

The walls were 15 ft by 15 ft externally, and 2 ft thick, and may have risen to 18-20 ft at the peak of a pitched roof (some 8 ft above the highest wall remains). The sluice gate, spill race and 1:10 sloped, 20 ft by 2 ft mill race were constructed in part with locally quarried St Bees sandstone. The stonework had lost much of its clay soil bedding and almost all lime mortar pointing. Joints were raked out to a depth of 1-4 in, and walls stabilised with stone fragments and pointing with hot lime mortar. At risk stonework in window and headrace areas are now partially supported by rebars. Stones and rocks found in demolished areas have been used to make drystone walling to the height in the 1968 photograph.

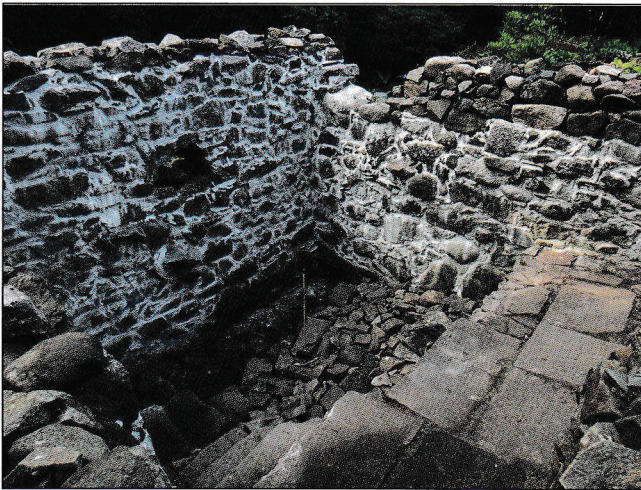
Fig. 6. View of internal head race and water channel. Yellow pole shows position of central spindle bearing.

The wheelpit floor had a thick layer of clay-rich soil and the water flow channel is clearly identifiable. The stonework in the centre of the wheelpit has a circular cavity that may have retained a bearing for the vertical spindle of a sole tree (horizontal pivoting beam). Its position is shown by the short yellow pole.

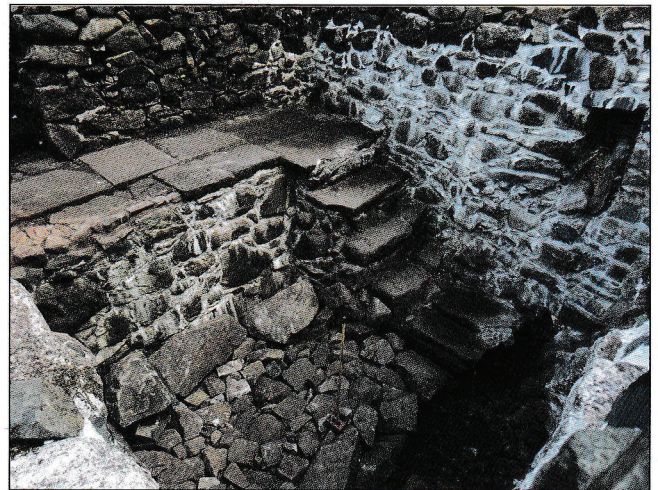
Fig. 7. Platform and base for beams across to riverside wall and flooring. Stone steps to tail race and wheelpit.

The entrance opens to a 11 ft wide by 3 ft deep sandstone flagged platform, with stone steps on its downstream side descending to an 8 ft by 8 ft lower storey or wheelpit.

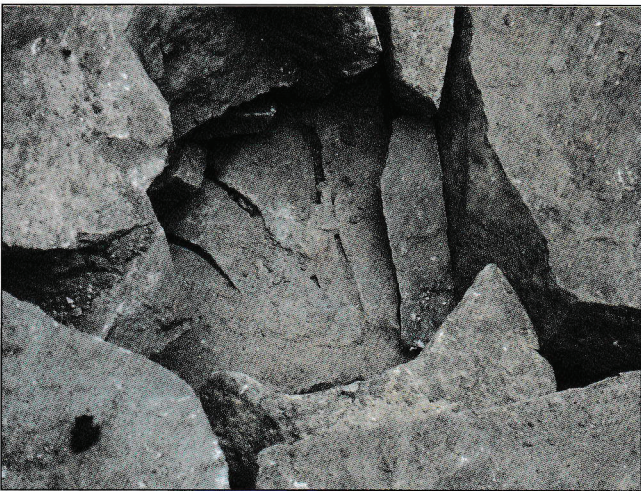
Fig. 8. Possible spindle bearing cavity in wheelpit stone floor.

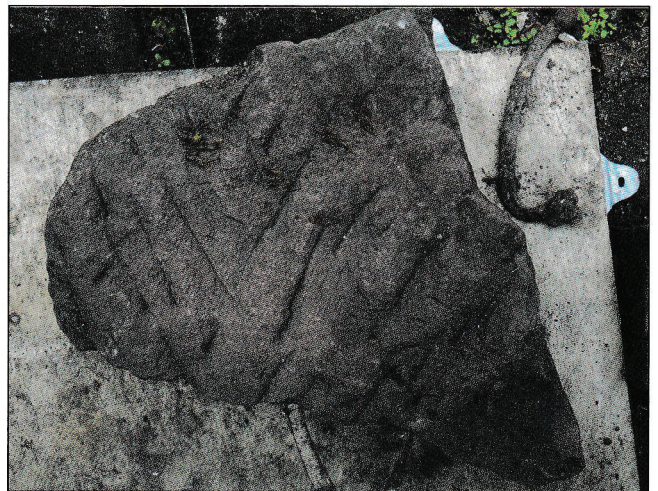
Fig. 9. Fragment of harp patterned millstone.

A fragment of a harp-patterned millstone (9 in x 9 in x 10 in triangle and 4 in thick) was also uncovered. It is red-brown in colour, tough, fine-medium grained, porous micaceous sandstone, probably from St Bees. A very worn, larger piece (2 ft wide and 3.5 in thick) partially supports the downstream window lintel. Several other shaped, gritstone-like fragments were found.

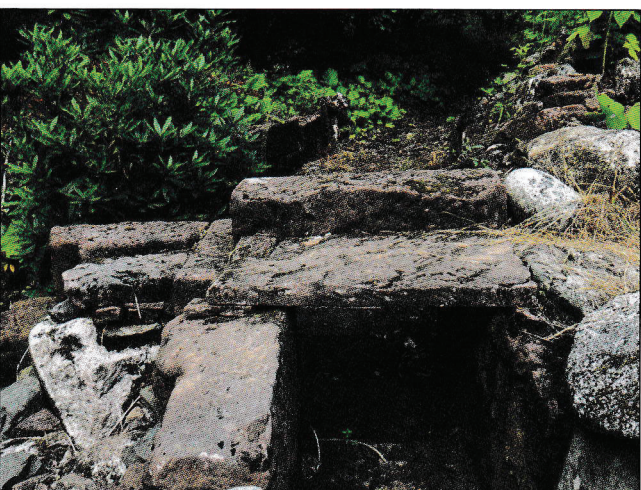
Fig. 10. Shutter board housing controlling flow down mill race.

The leat may have had relatively constant water flow from a weir on the River Irt. Closing the spill race and lifting the mill race sluice boards would have allowed water to stream down the relatively narrow 20 ft long, 1:10 sloped, 2 ft wide mill race. Then, focused and concentrated to about 6 in wide by a large granite pinch stone, it ran down the 1 ft by 1 ft steep head race at the base of the 2 ft thick mill wall. As the torrent crossed the internal 11 ft wide, sloped wheelpit floor it would have turned the mill mechanism. It would have exited through the 15 in wide and 2 ft deep tail race at the base of the opposite 2 ft thick wall, then run some 15-20 ft into the river. This layout and its dimensions appear suitable for a simple horizontal paddle wheel.

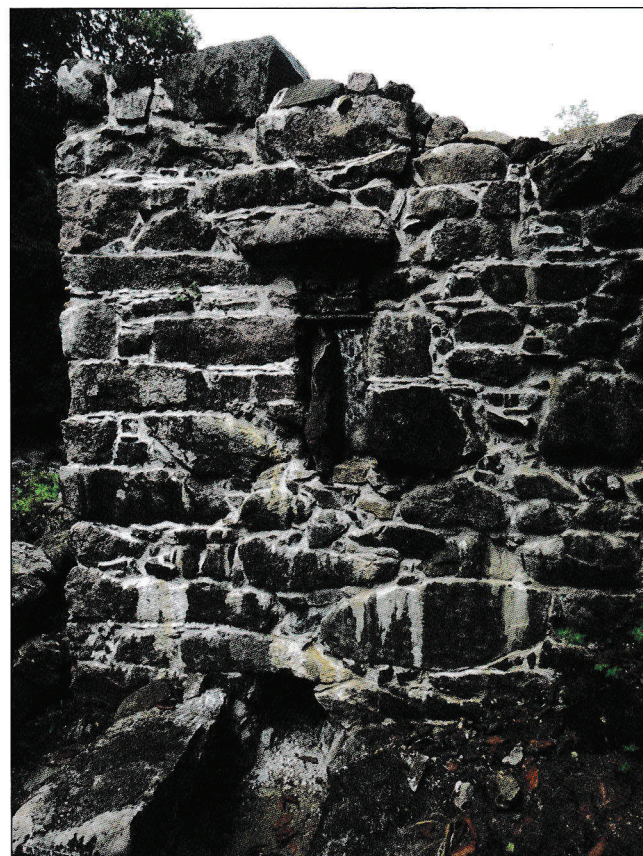
Fig. 11. External downstream wall, window and tail race.

The spill race had been washed apart and stones removed, but remarkably much of Lords Mill was found to have survived deeply buried under stones, soil and thick vegetation. Sandstone flags, rocks and slate tiles set in the window of the tail race wall had saved the lintel and stones from falling, and the riverside wall was supported internally and externally by boulders and large rocks.

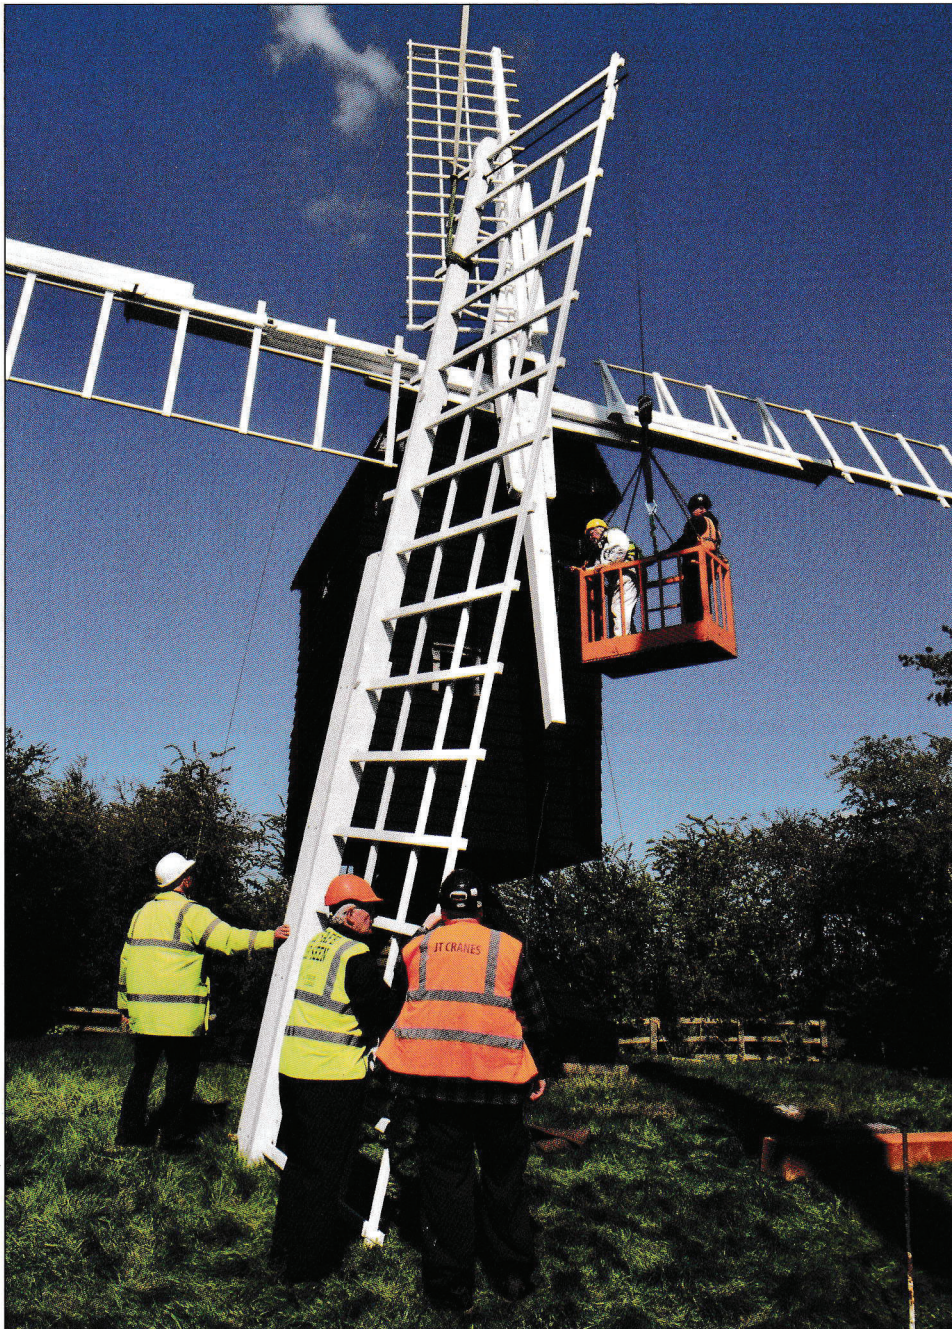
Fitting the last sail to Great Gransden post mill (Cambridgeshire, UK) by Gransden and Wicken millwrights on 19 April of this year (photograph by Alan Rowbotham).
