Felin Geri, Cwm Cou

Ruth Andrews

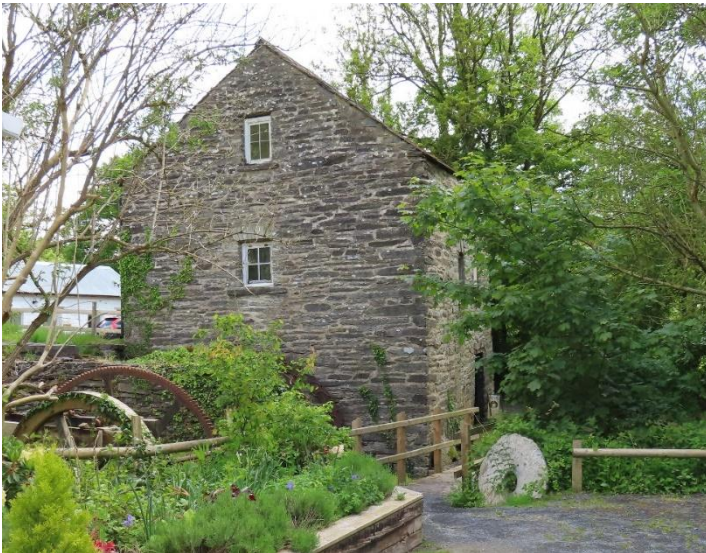
When Edwin Course took a group of industrial archaeologists to Mid-Wales in 1989 they visited this 16th century watermill near Newcastle Emlyn which was producing semolina for the adjacent bakery. Edwin's notes mention occupied pigsties, geese, and other animals. Keith photographed two chained hawks, but not the mill! There was also a 19th century water-powered sawmill in a shed.

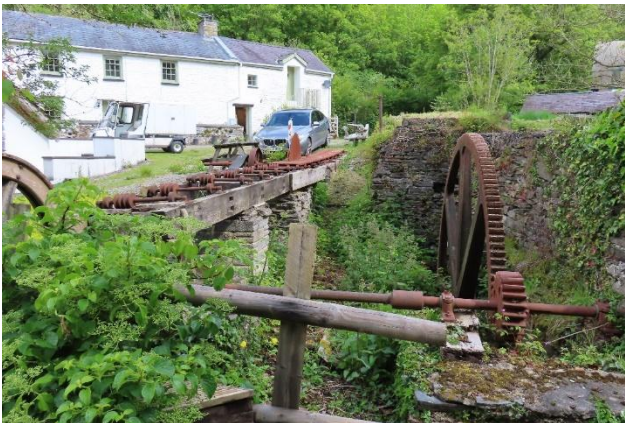
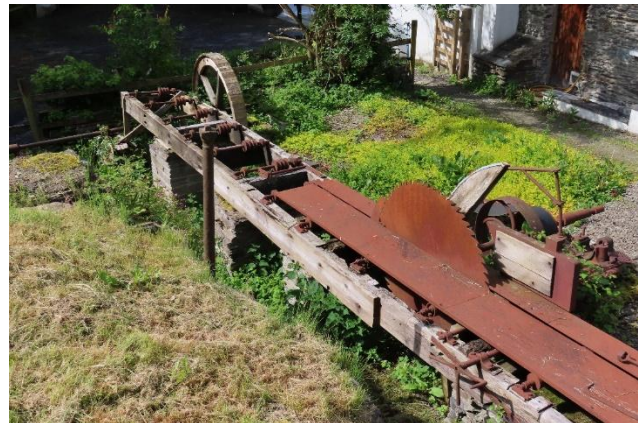
In 2010 the corrugated iron roof of the sawmill shed collapsed under the weight of snow, making it much easier to photograph this feature.

It had an overshot waterwheel dated 1880 which drove the sawmill through a pit wheel and pinon and then a belt drive. This sawmill wheel, on the right in the picture, is in much better condition, and completely separate from the similarly-sized backshot waterwheel, on the left, for the corn mill, which is said to be dated to 1872.

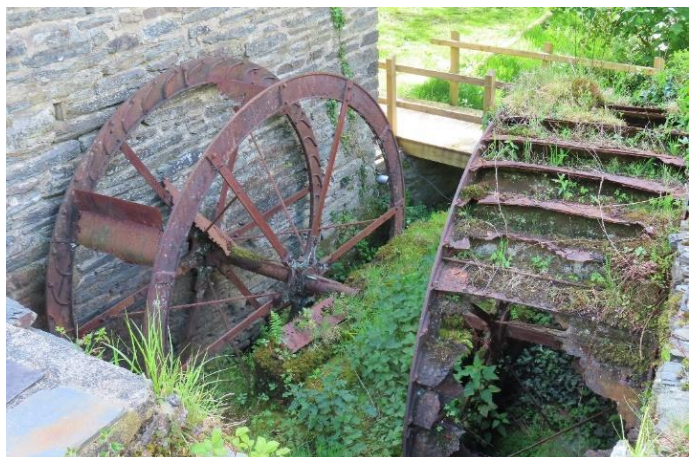
(The Coflein listing NPRN 406737 describes them both as overshot, but this is clearly wrong.) They have two adjacent water supplies, each controlled by its own sluice.

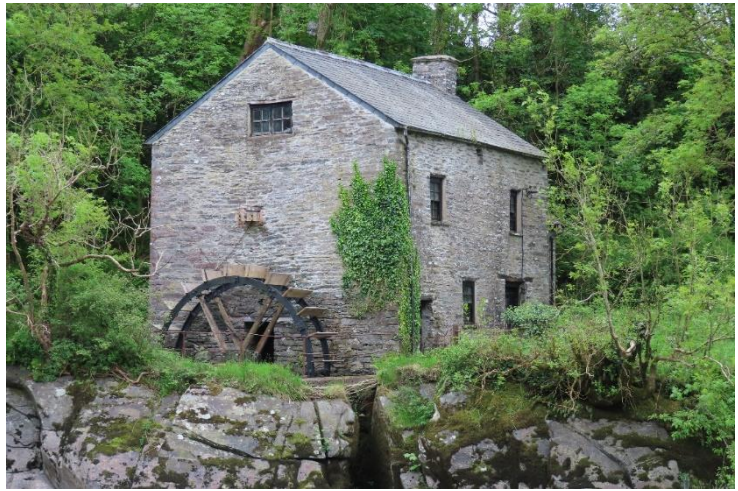
It has an undershot timber and iron waterwheel which has recently had new floats fitted. SPAB says it drives two pairs of millstones, one for barley, the other for oats. It last worked commercially in 1964.

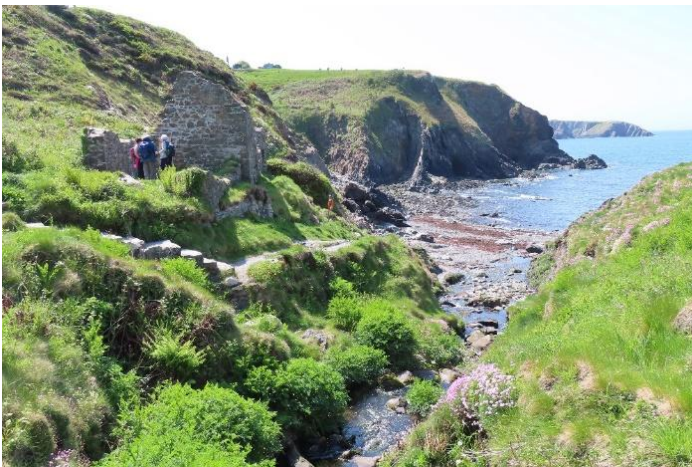
Melin Trefin is a ruin in a splendid location at Aber Draw containing a pair of millstones. During the eighteenth century there were dozens of mills like this one dotted around the Pembrokeshire countryside. According to Coflein, there was an overshot wheel on the western gable. The mill is believed to have ceased working by 1918.
