Sherborne Mill – Update

Reports by Harry Clarke

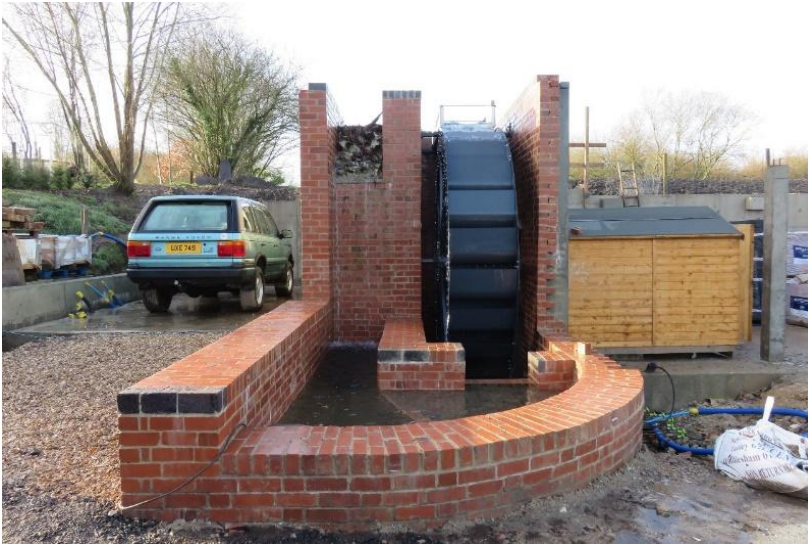
21 November 2018: The wheel was commissioned yesterday and operated at full crack overnight generating power. Checking it this morning though it seems to have shifted along on its axle by about 12cm despite the taper locks that should lock it to the keyway. We have therefore dropped the level down again.

30 November 2018: Well the wheel remains silent as I write whilst we think carefully of the next move. Apparently, the first wheel the firm built was fitted with a taper lock on both side securing the wheel to the axle but this created issues with the wheel when expanding and contracting. The second only had one taper lock and this proved perfect, the wheel could flex slightly yet remained in a fixed position on the shaft. Ours followed the same principle and the results are obvious. My own thoughts on this is that everything was greased so well that the taper lock didn't actually bite. This was compounded by the fact that the launder wasn't levelled up perfectly and therefore delivered marginally too much water to one side.

11 December 2018: The engineers yesterday moved the wheel back along the axle (fortunately it was well greased) and then locked it securely into place. We set it going yesterday evening and it has been running without fault since, generating power.

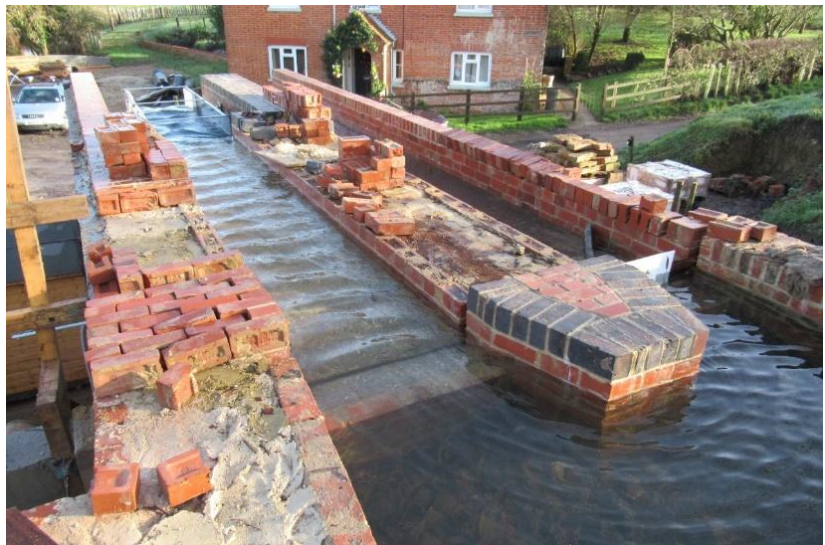
Editor: The standing wave in the launder is intriguing. I thought perhaps it is created by the wheel rather than the wind, but John Christmas suggests it is due to the lip in the launder.
