Overton Silk Mill Site

Ruth Andrews

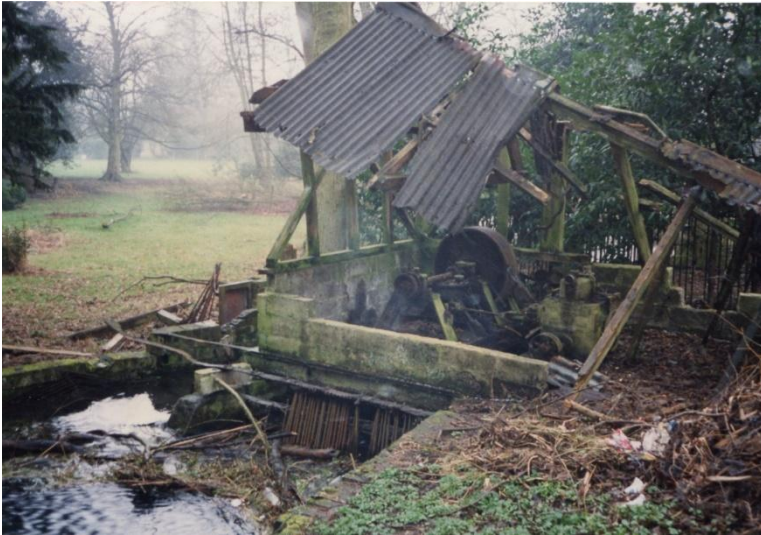
In 1994 I had taken a photo (*left*) of the site which shows the installation at an earlier stage of its decay. The metalwork has now been hauled out of the river (*photos below*) and the associated brickwork removed. It powered a generator and pump, probably installed in about 1910 to supply water and electricity to Southington House.

During October 2017 the Environment Agency/Natural England did some work landscaping and restoring the river bed at the Overton silk mill site. This involved damming the channel, and removing a small waterwheel, Armfield turbine, and associated brickwork.

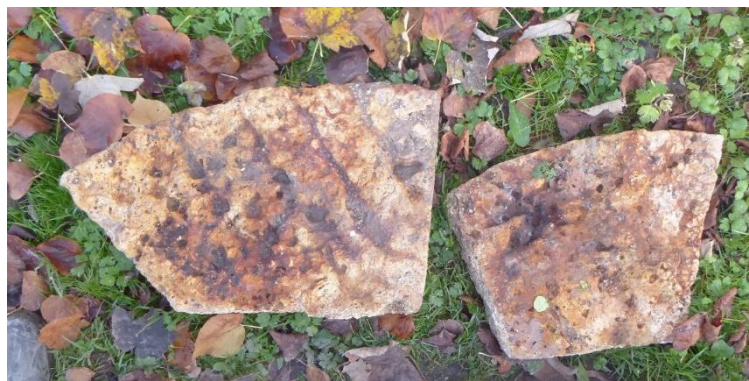
Community Volunteer Project managed by Overton Parish Council had been set up to examine the river bed while it was dry. Amongst the early finds were two pieces of millstone which he needed help to identify. This photo is of the newly excavated stones.

Now they have been on dry land for a couple of months they are obviously French burr stones but they are quite weathered and pitted, and had picked up a lot of loose mud and gravel during their time in the river, making them look disconcertingly like gritstone.

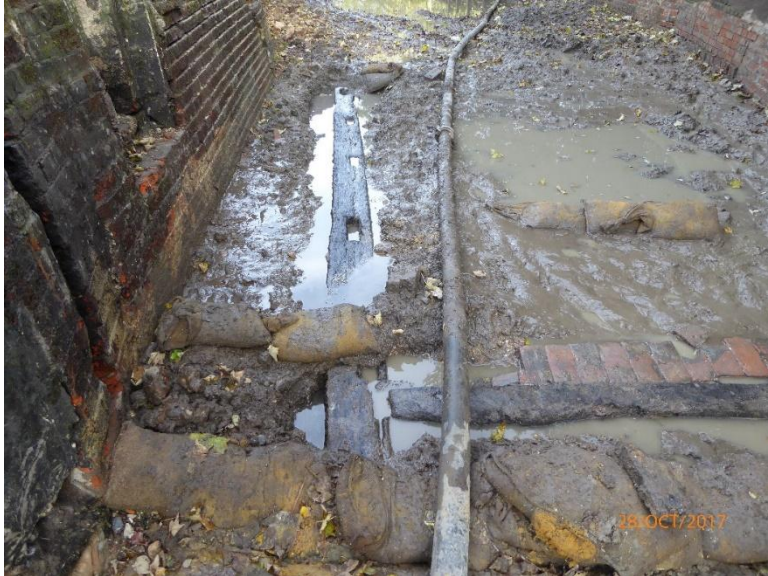
As the workforce cleared the accumulation of silt from the site, they also found several stout timbers in the river bed. Dendrochronology established that these were felled between 1760 and 1793, making it almost certain that they were associated with the silk mill, built in 1769.

They are situated just upstream of the wheelpit, and so may be part of the sluices and a training wall.

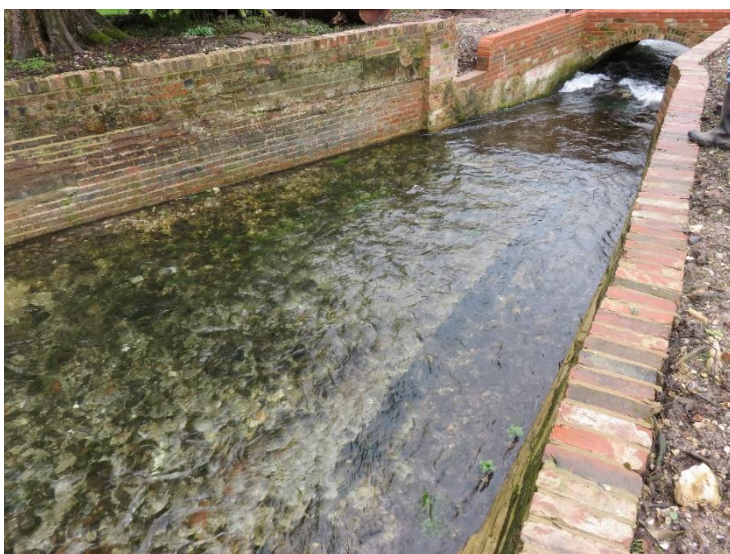
In addition, the curved stones of the silk mill's wheelpit were uncovered and removed.

Richard had the presence of mind to use one of the stones to establish the waterwheel's diameter, which was 217cm, about 7ft.
