Quidhampton Mill, Overton

Richard Waldram

Part 1: History and Building

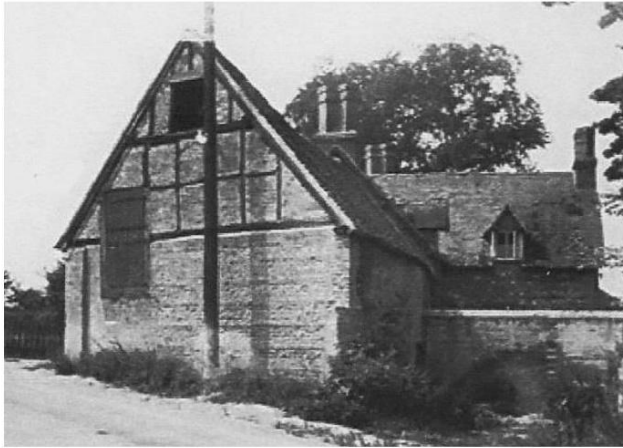
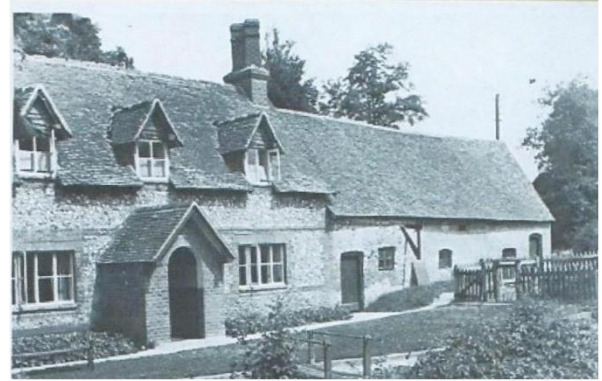
Historic England Archive No 1731_035

The views above were taken in 1951. The left one shows the timber framing and the access door to the stone floor from the road. The massive brick buttresses and the tie rods (*below left*) must have been put in after this date. It had been evident for some time that the roof was in danger (*photo below right*, Tony Morris www.overtonpictures.com, taken in 2005). In 2007 the whole mill house was encased in scaffolding and the roof covered with tarpaulins for a couple of years.

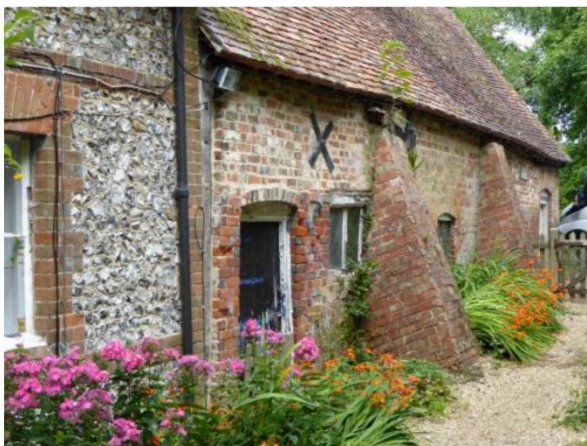
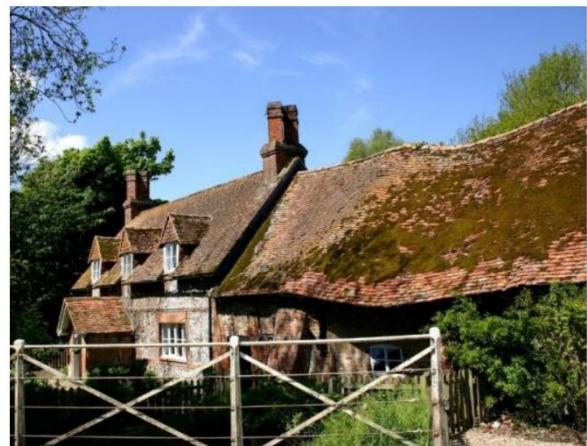
I found that details of the planning application for repairs were still on the Borough Council website. There were three reasons for the collapse. Two of the tie beams had been cut resulting in outward thrust on the walls. Some of the trusses had failed and the purlins were not of adequate scantling. The buttresses and tie rods (*above*) had failed to solve the problem.

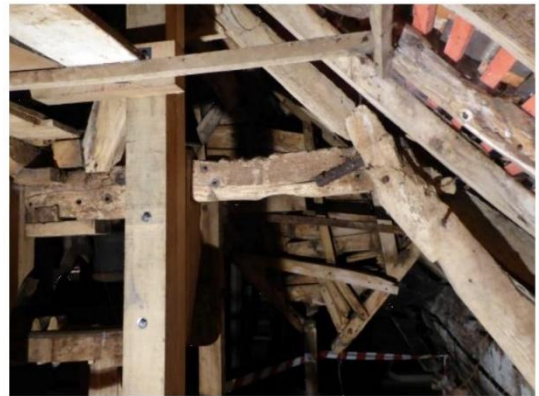
The photo above shows one of the new oak posts supporting the purlins from ground level.

cruck and the wall. Eventually, four of the crucks failed, the south wall began to lean, the purlins sagged and the roof collapsed. New purlins were put in supported by vertical posts from ground level, leaving the original roof structure otherwise intact. This is how the building was saved.
