Technical notes on Barton Watermill, Old Basing, Hampshire

by Luke Bonwick, June 2009

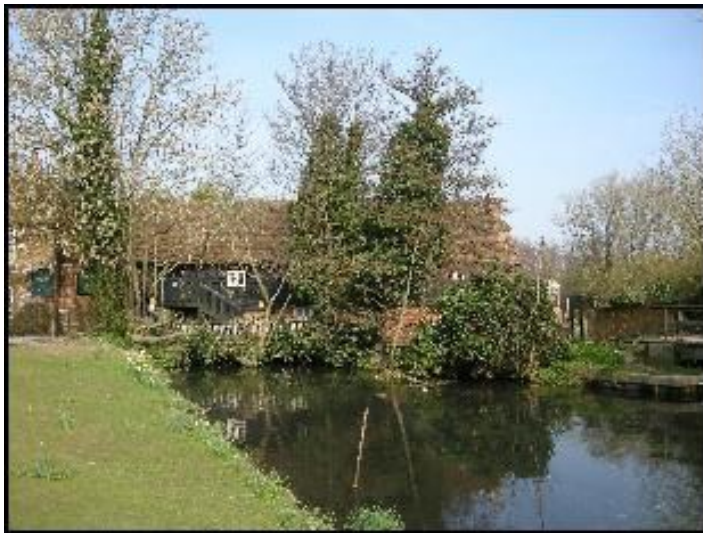
Barton Watermill Photo Sheila Viner

The mill's main range adjoins the mill house and runs NW-SE, straddling the river. The head pond is positioned to the south of the mill and the bypass channel runs around its south-eastern end. The original structure, which is timber-framed, survives amidst several later brick extensions. Weatherboarding to the upstream elevation of the mill was formerly white-painted and is now tarred.

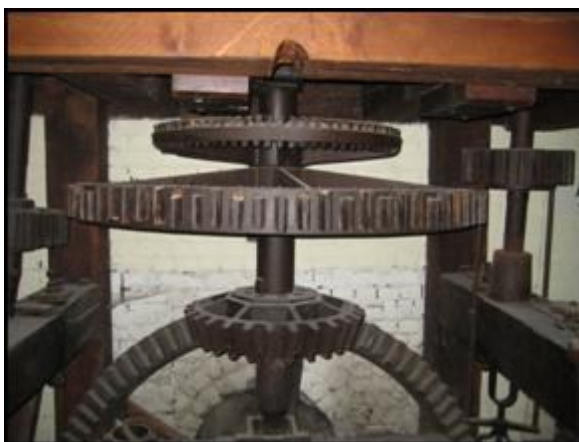
The all-iron NW set of gearing on the ground floor, set up to drive two pairs of millstones. Note how the crown wheel is set directly above the great spur wheel on the upright shaft.

The gearing driven by the NW waterwheel is almost entirely of cast iron, with wooden cogs in the pit wheel and the great spur wheel. I was surprised to see that the cast iron upright shaft terminates at stone floor level and, as a result, the crown wheel is mounted directly above the great spur wheel, below the first floor. The crown wheel appears to have driven a single layshaft on its NW side, which is now missing.

The NW set of gearing has pitch measurements as follows:

Pit wheel cogs: About 2.875" pitch (5" face and 1.5" depth), indicating a date of 1830-80.

Great spur wheel cogs: 2.375" pitch (4.125" face and 1.375" depth). Dating: pre-1810 to 1840.

Crown wheel 1.5" P (3" face and 1" depth), indicating a date of 1880 onwards.

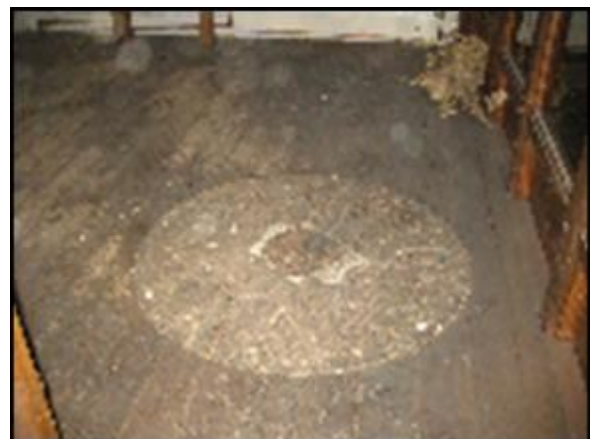
The shaft terminates at stone floor level. One of the bed stones from the NW set of gears, set flush with the first floor. Photos © by Luke Bonwick

Each waterwheel drove two pairs of stones, which were positioned on the upstream and downstream sides of each upright shaft. In the case of the NW set of gearing, the stones were mounted on the first floor. These have now been taken up and placed against the wall, with the exception of one French burr bedstone.

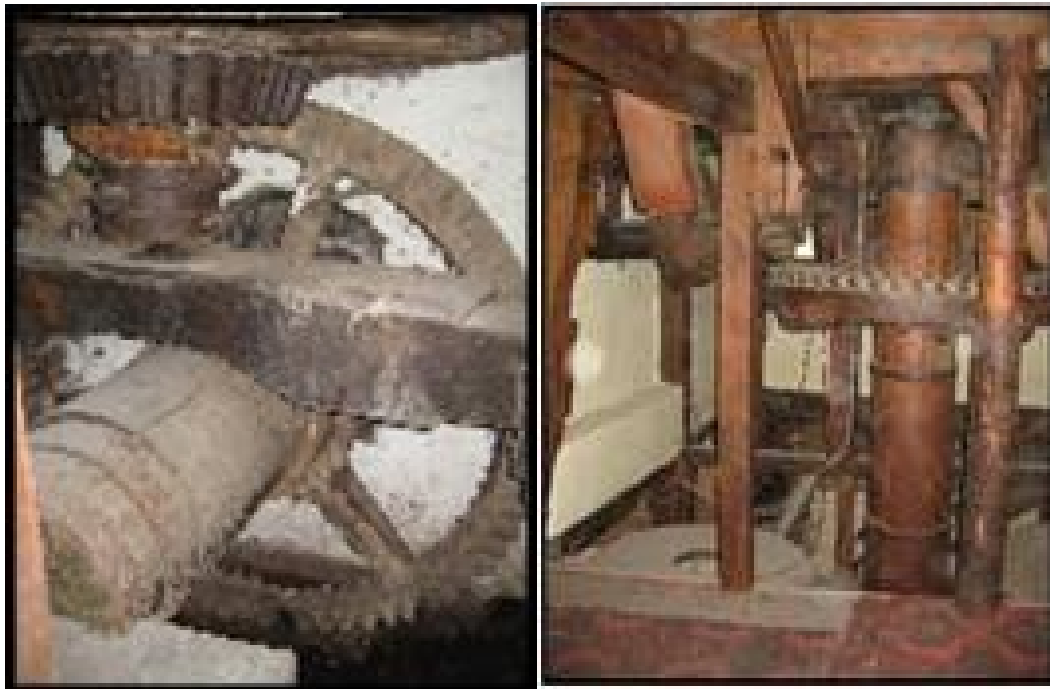
The wheel shaft, pit wheel and wallower of the SE set of gears - The SE set of gears.

Two pairs of stones are set on the hurst frame between ground and first floor levels. Above them, the crown wheel on the wooden upright shaft transmitted the power to two lay-shafts

The SW pairs of stones are supported by an elegant wooden hurst frame at a height mid-way between the ground and first floor levels. This set of gearing appears to be the older of the two. It has a cast-iron, 6-armed pit gear with morticed wooden cogs driving an iron wallower and a cast-iron, 8-armed great spur wheel with morticed wooden cogs driving wooden nuts. As may be expected, the pit and spur gears appear to have been cast in halves and bolted together in situ.

The upright shaft is of wood, with a compass-arm crown wheel set above the stones which transmitted power to two layshafts positioned on its upstream and downstream sides. The upright shaft, which extends to bin floor level, is of interest in that it appears to have been made from several timbers of small section joined together and secured with iron bands. During the process of conversion, all the internal woodwork has been liberally varnished with shellac or something similar, making details of the construction less clearly visible.

The SE set of gearing yielded the following measurements:

Pit wheel cogs: 3" pitch (5" face, 1.75" depth)

Great spur wheel cogs: 2.75" pitch (4" face, 2" depth)

Crown wheel cogs: 3" pitch (3.5" face, 1.75" depth)

A pitch of 3" suggests that the crown wheel was installed pre-1810, and a pitch of 2.75" for the spur wheel is consistent with this date. The pit wheel has a pitch of 3", indicating that it, together with the wallower, was replaced later than 1810 but before 1880.
