Fallgate Mill

Ruth and Keith Andrews

Fallgate Mill and the Clay Cross Company

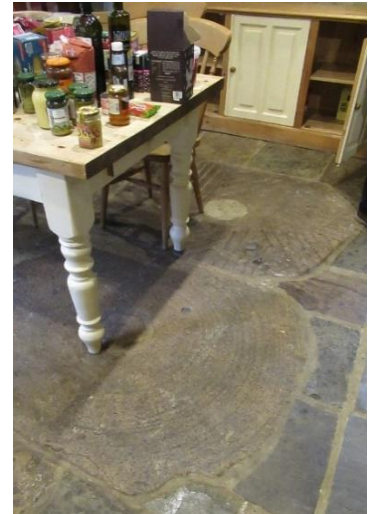
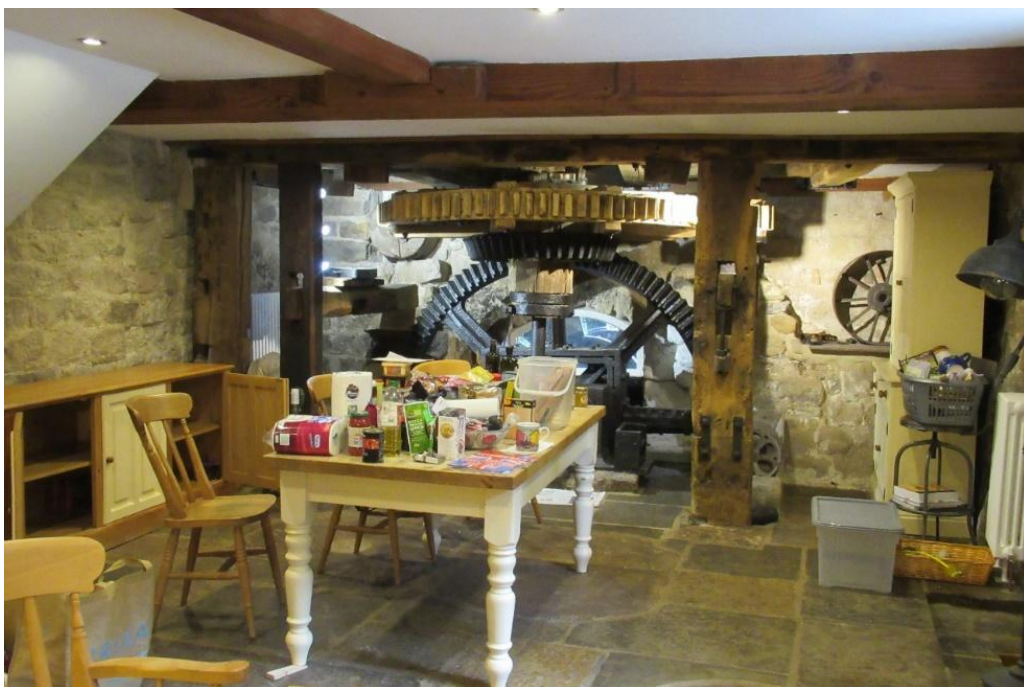
(Right) The kitchen floor has recently been relaid using worn out millstones. The nearer one must have been used for grinding fluorspar.
