## Hockley Mill Sluice Rebuild

**Ivor New and Mick Edgeworth**

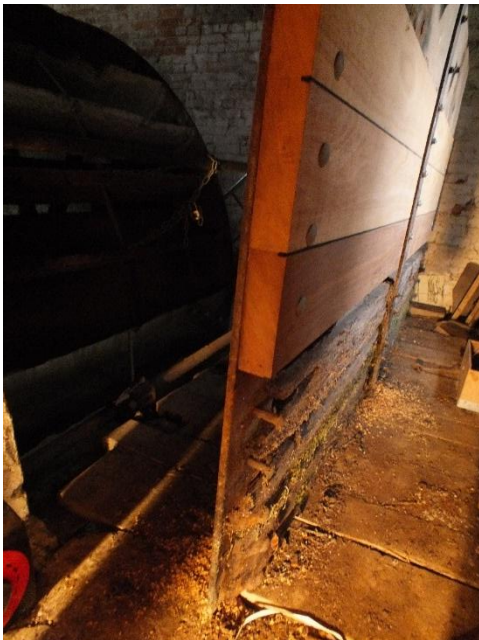
The initial task was to remove two cast iron racks, part of the operating equipment, from the face of the sluice. Prior to removing them their location was marked on the top board of the sluice. Careful measurements were taken throughout the work. The remains of a few boards immediately below the top board were then stripped off, leaving the lower boards in place to maintain the alignment of the iron strapping.

Work continued by cleaning the heavy rust scale from the iron straps that locate and reinforce the boards. The new boards were installed working downwards from the top board, each having its sealing strip inserted and being carefully aligned and clamped in place before being drilled and bolted to the existing iron straps. This process was repeated, removing old boards as necessary, until all the new boards were in place. New metal rubbing strips were then slotted into place at either end of the sluice to protect the timber where it was especially prone to wear.
