Le Moulin de Gô

Ruth Andrews Pictures by Mick Watson

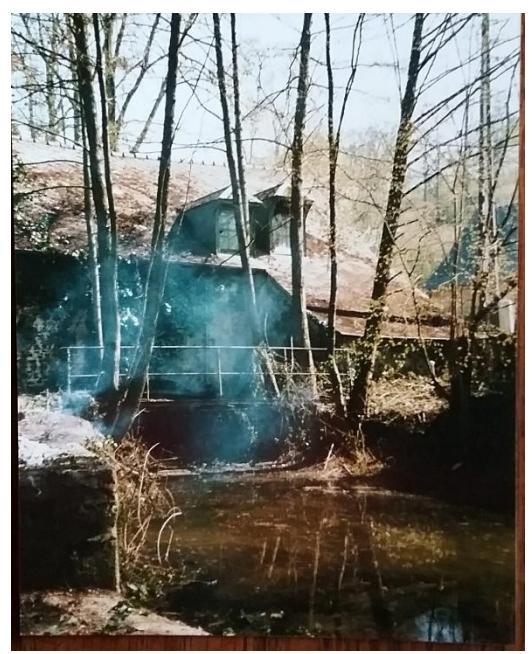
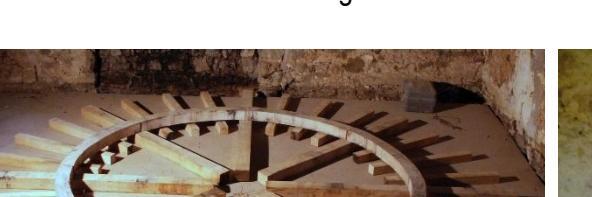
Restoration work began in 2012 and as nothing had been done for over 20 years chain saws were needed to even approach the building, and the tree roots growing out of the walls had done a lot of damage. As Mick says ."I needed to rebuild a lot of walls". Within a month the sluice gates leading from the main river were open and the mill had water flowing through it once again.

Compare this picture with the restored building at the start of the article.

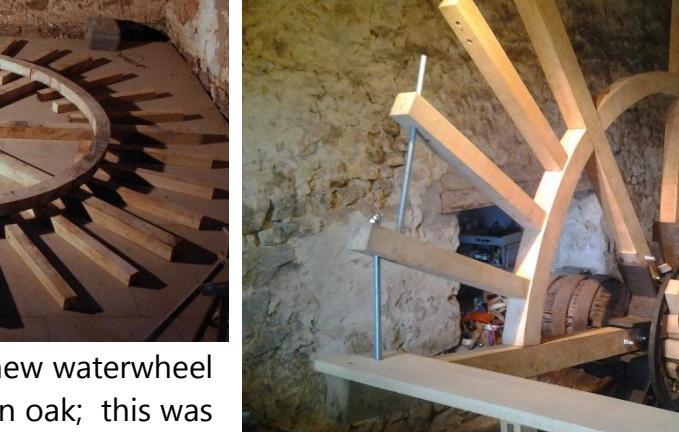
Late in 2013 a completely new waterwheel was constructed using green oak; this was finished by 2014.

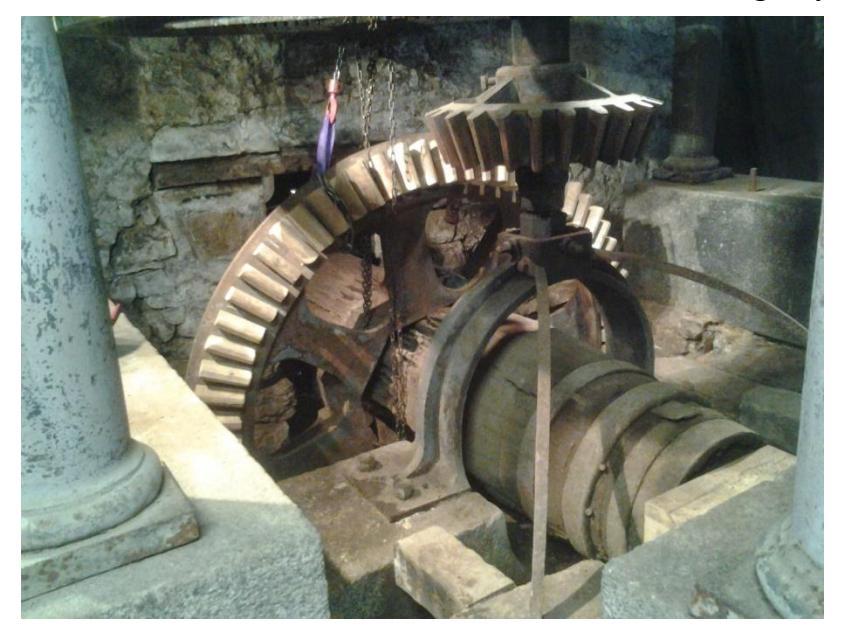
The next job was to sort out the drive mechanism. The rotten teeth on the metal pit wheel and crown wheel were replaced using acacia on the drive wheel main and cormier (Sorbus domestica, service tree) on the smaller Cormier is very gears. difficult to find, but luckily a furniture maker in Mick's local village had some, and made 250 teeth which were fitted by Jean-Claude.

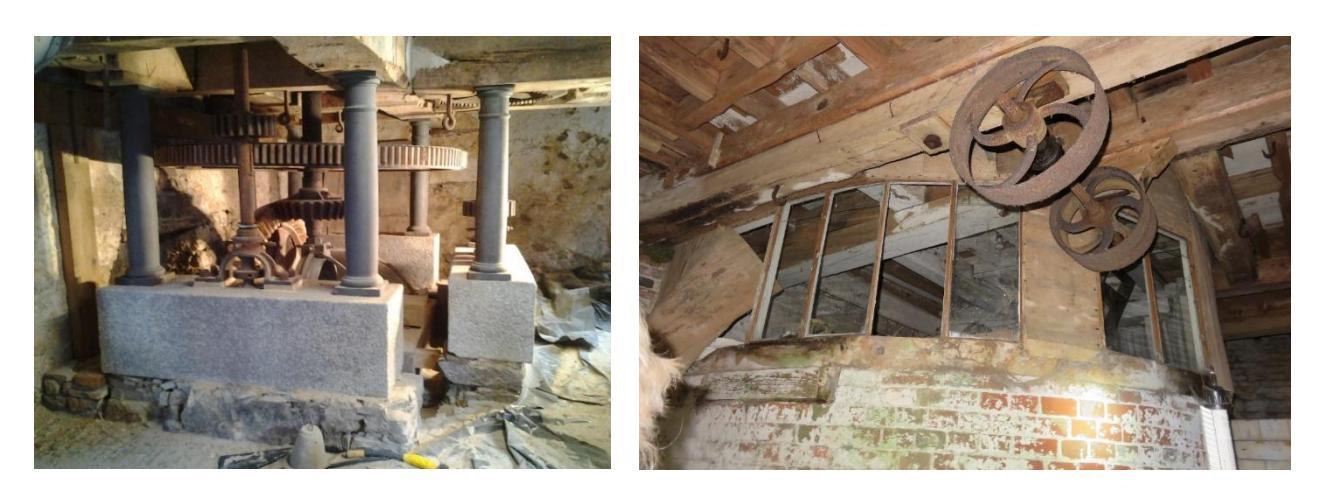
When I first saw the picture in this article of the poquerie (*repeated*, *above left*) I immediately thought of Soberton mill, which –as reported in Newsletter 120 – has a very unusual curved wall round the space which the pit wheel, wallower, and great spur wheel would have occupied (*above right*). The gears are long gone, but the stone spindle bearings are still in place on top of the wall to give a clue to the function of the structure. The prominent pulleys are part of the belt drive from the more recent turbine.

"The mill takes place on a derivation of the Erve. On the ground floor, the poquerie contains the mill's transmission mechanism, with the pit wheel, the idler gear, and a large gear wheel that drove the axes of the three wheels. Above, the floor's floor joist is supported by cast iron columns resting on a stone chest, delimiting a quadrangular space. A wooden staircase provides access to the attic which still houses two pairs of millstones out of three, protected by wooden chests, archings."
