Visit to Harry Clarke's Hydro Installation, 6 July 2024

Ten members visited the hydro-installation (mill!) at Sherborne St John. We were warmly welcomed by the owners Harry and Devika, and would like to thank them for being such informative and enthusiastic hosts.

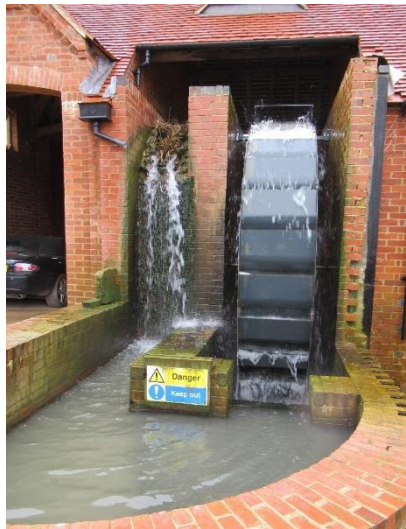
In action – Keith Andrews

The wheel: Overshot, 3.8m diameter steel constructed as a specialised one-off by Smith Engineering of Maryport, Cumbria. It is rated at 3.4Kw at 8rpm. It was commissioned in 2018.

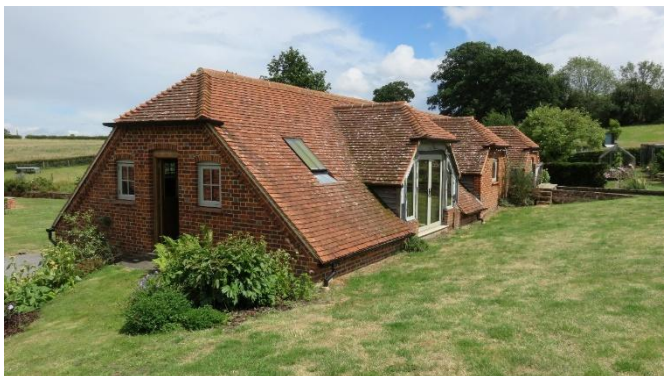
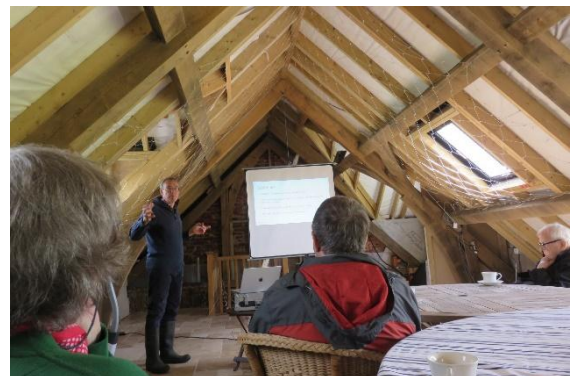
The mill building forms the dam; inside is a function room – Ruth Andrews

Why rebuild the mill? The earth dam was unstable and so a retaining wall was required; the retaining wall needed to be L shaped, and piled, given the poor soil condition; water was flowing through the middle of the site anyway.

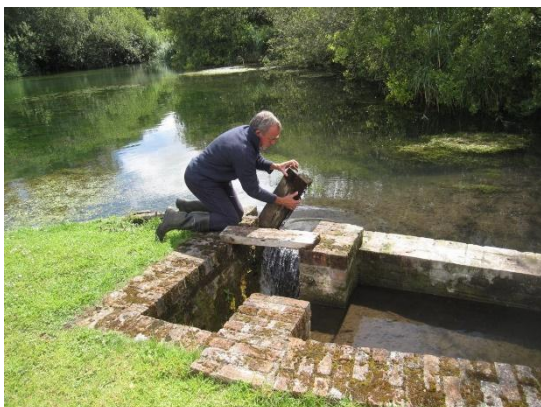
Pond and overflow – Sheila Viner

Then we had the 'tour' to see the mill pond and its overflow system, the inlet for the ram pump, the headrace with its automatically controlled sluice, and the garden where the outlets from the underground overflow spillway and tailrace have been made into features. After admiring the wheel and cascade at close quarters, we went into the building to see the gearbox, alternator, and specialised electrical control equipment.

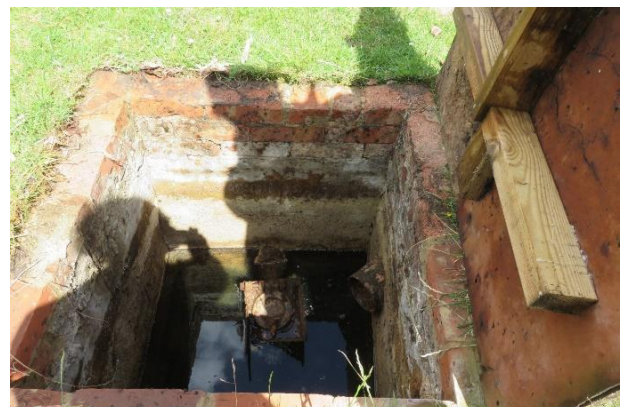
Ram pump inlet – Keith Andrews

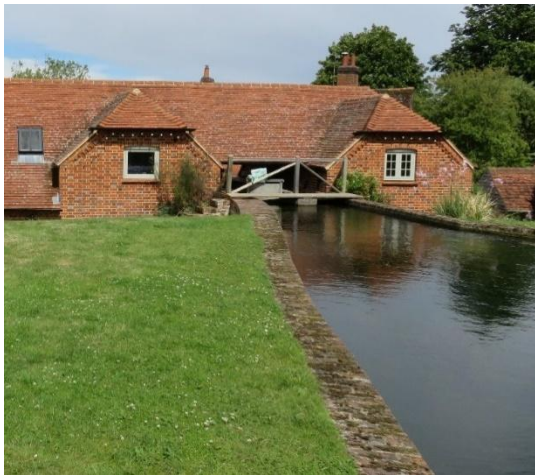
Headrace – *Keith Andrews*

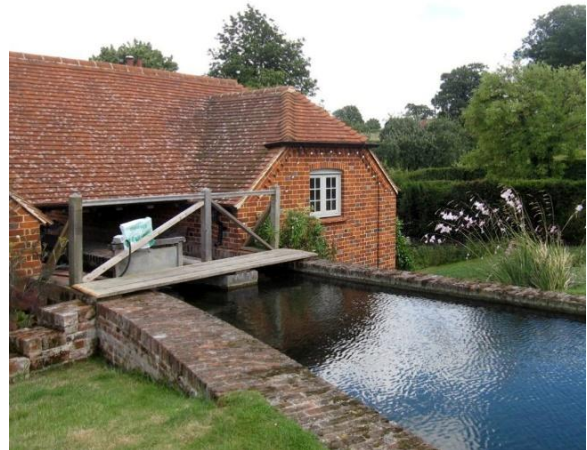
Automatically controlled sluice – *Sheila Viner*

Things that worked: Spherical roller bearings; they are bombproof; the Brevini Italian-made gearbox; the electric synchronisation box from Sustainable Control Systems; home-made automatic electric control actuator (using hospital bed parts!) for moving the sluice gate.

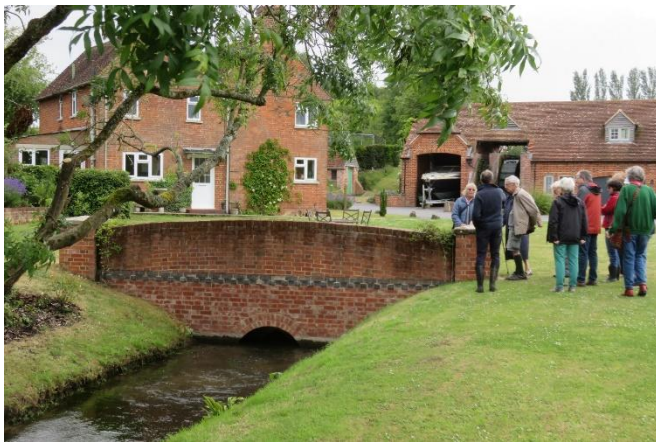
The tailrace outlet is a garden feature
Keith Andrews

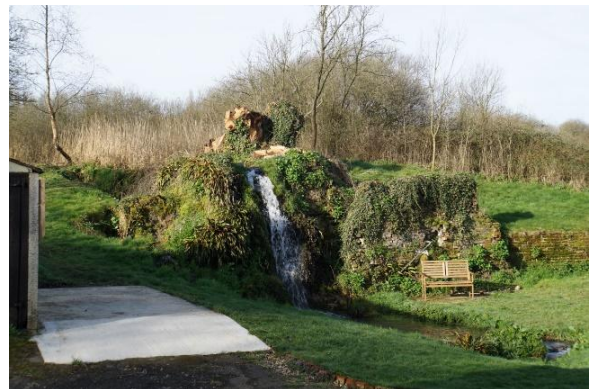
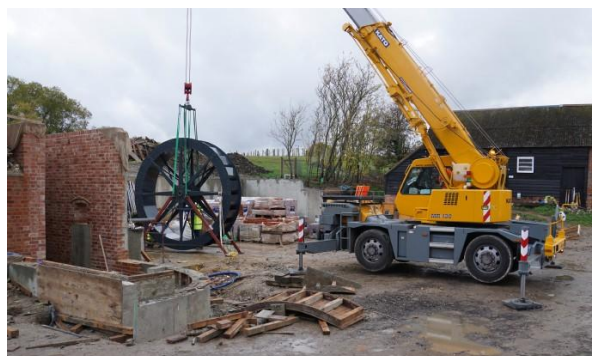
Top: The site as found in 2015
Bottom: Installing the wheel – *Harry Clarke*

The site: It was Sherborne (Corn) Mill, an original mill site dating back to Domesday. The 1797 mill was in ruins; the bypass tunnel, control sluice, and wheel pit remained but in poor condition. The mill pond was full of silt and reeds.

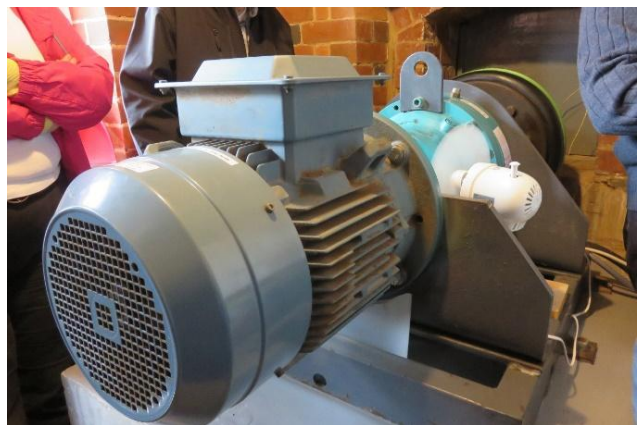
Alternator, gearbox with fan, Fenner-flex rubber coupling – Keith Andrews

- The torque involved is colossal.
- Do not weld anything – flexing will cause propagation of the inevitable microscopic cracks in welds.
- Mechanical devices wear and fail – have a maintenance routine and a budget.
- Ensure there is a designed break point, such as the rubber coupling in this case.
- Gearbox cooling is required. There is a mechanical fan!
- Safety is a factor.

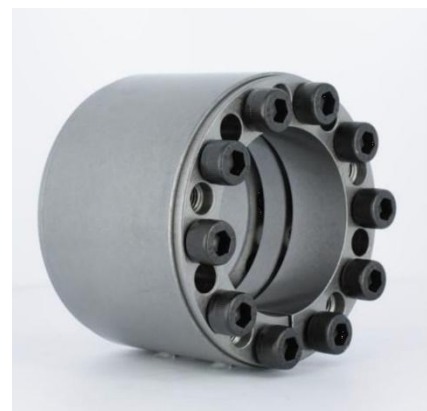
The wedge grips by utilizing axial compression to hold the hub in place, while simultaneously using radial pressure to generate an interference fit between itself and the shaft

- Dunlop tyres for the break point – use genuine Fenner-flex.
- The undersized shaft, originally 80mm, replaced by 100mm.
- Keyed or welded connections between the hub and shaft, replaced by a new hub connection – a radial wedge with B-loc compression fittings. The failing welds were the cause of a catastrophic failure in January 2023.

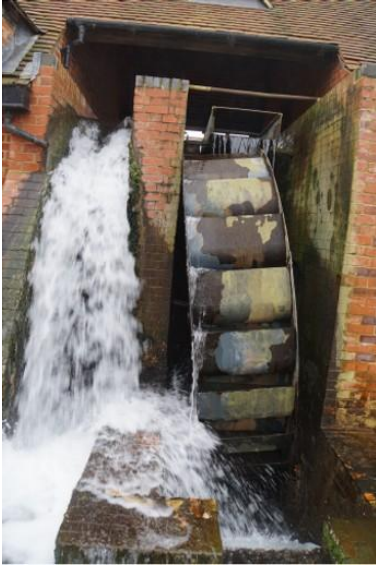
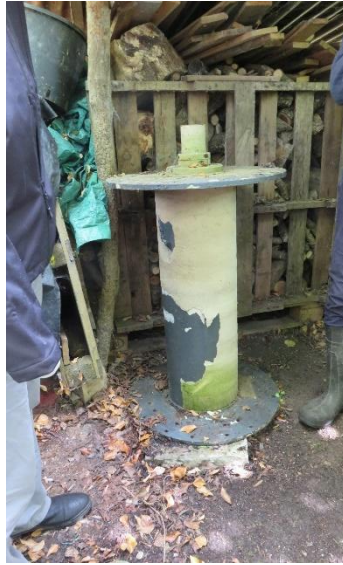
Far left: The catastrophic failure – Harry Clarke

Left: The broken axle (with limescale build-up) – Ruth Andrews

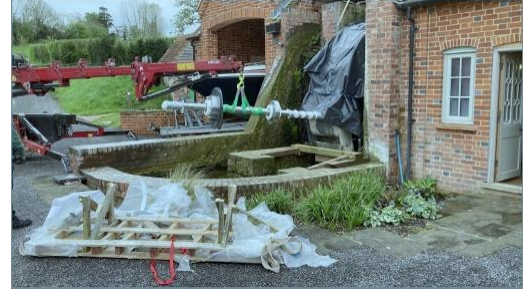
Below: With a roof over the wheel, a special 'spider-crane' was needed to extract and replace the wheel after the axle broke – Harry Clarke
