## Bunessan Mill, Isle of Mull

**Ruth Andrews**

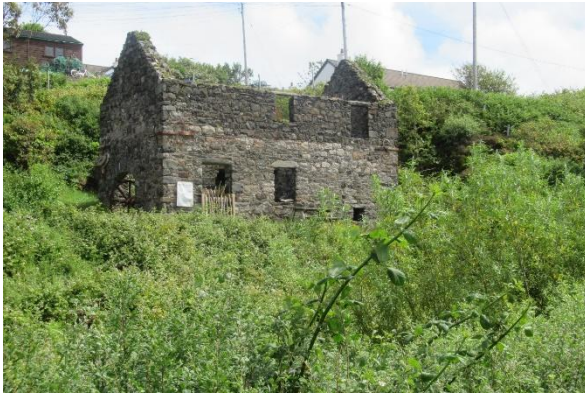
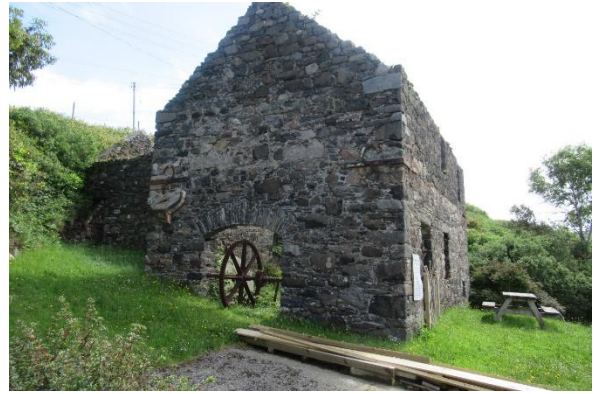
As originally built in the 18th century for the landowner, the Duke of Argyll, it was a single storey building with an 11ft diameter waterwheel. The building was enlarged in the 1830s to provide a second storey and a drying kiln set at 90° to the rear of the main building. The wheel was increased to 14ft in diameter and a lade or channel cut to give a 20ft head of water from a natural pool half a mile upstream. Crofters bringing their grain to be milled were expected to help the miller by operating the sluice gates.

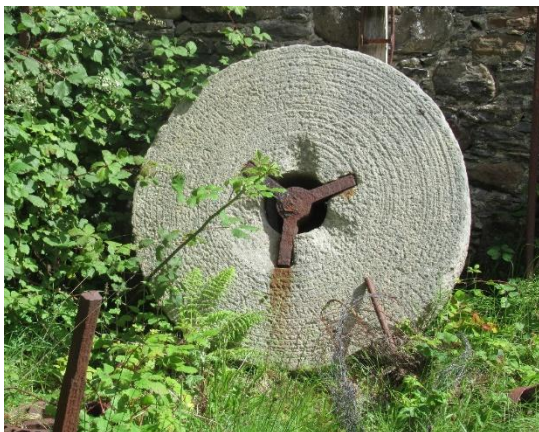
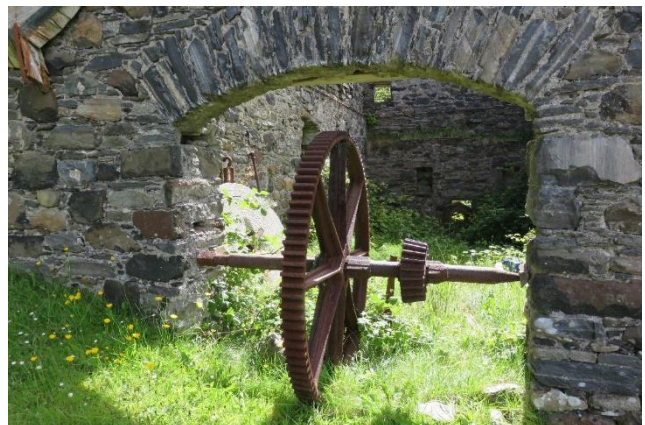
As you can see the upright shaft, great spur wheel, and wallower have been repositioned to form a decorative feature, and 2 millstones (with no visible dressing so they must be the shelling stones) are propped up inside the mill. We did not see the third stone which was said to be French quartz. The vegetation was too overgrown to let us see into the wheelpit.
