## Sherborne Mill, Sherborne St John

**Ruth Andrews**

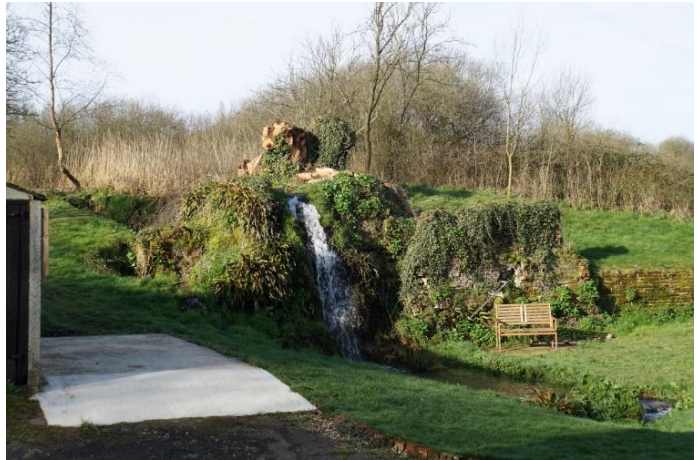
Note the reed bed in the silted mill pond and a woody bole – the remains of a large willow tree that had cracked open the masonry leaf

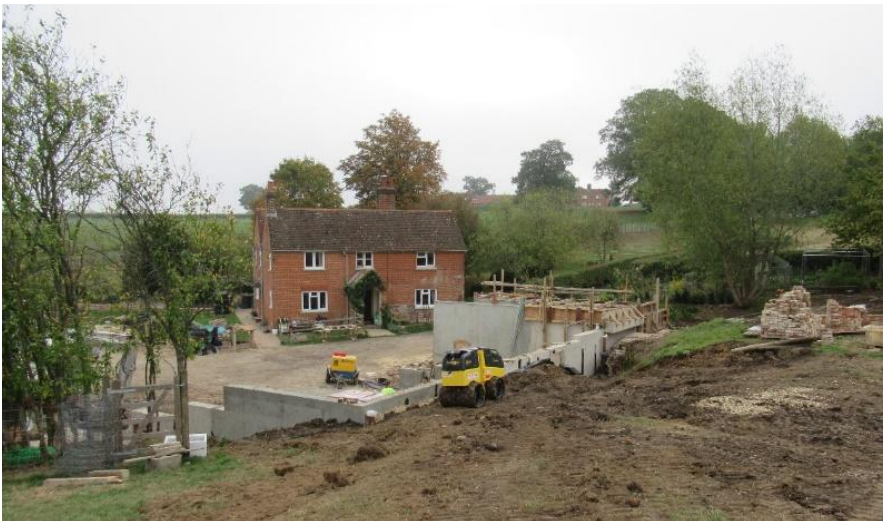
When Keith and I visited the site in October work had started on a new building and wheelpit on the site of the mill. The concrete currently visible will soon be disguised with the original bricks. This photo was taken from the mill dam, with the mill pond off to the right.

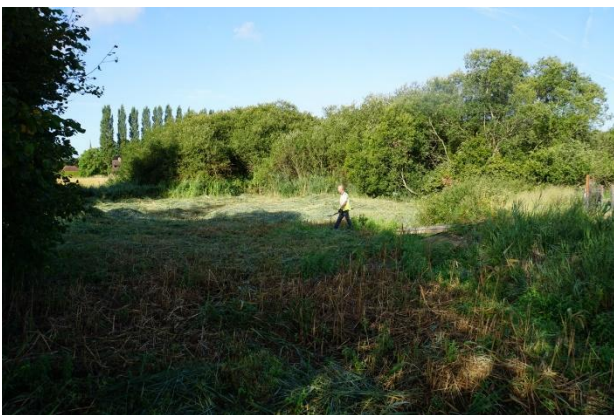
The silted-up mill pond – you could easily walk on the reed bed which had grown up

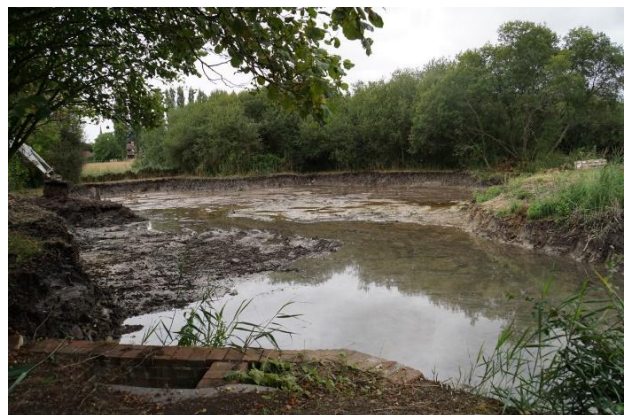
The mill pond after 4500 tonnes of silt had been excavated

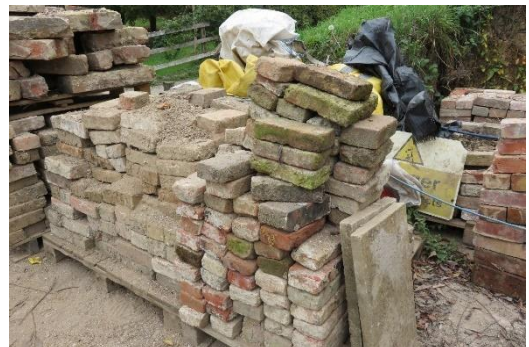
Many of the bricks being used to clad the concrete come from the site, the remnants of the 1797 mill and even older buildings

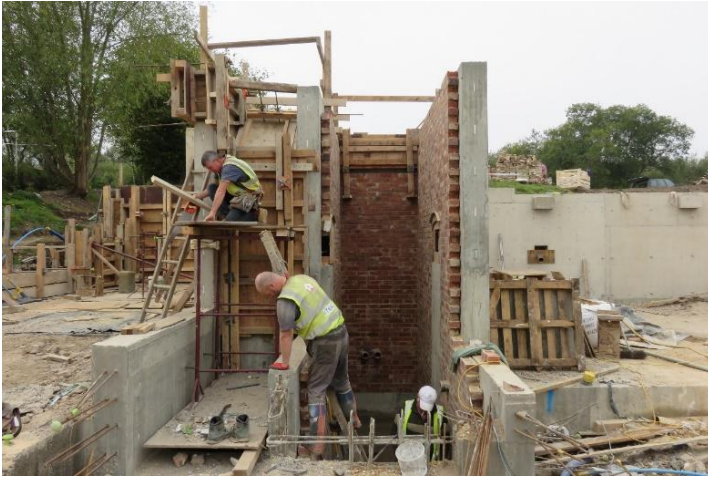
The wheelpit under construction

The building we are putting back is going to contain an epicyclic gearbox and generator attached axially to the wheel but is largely going to be used for vehicle and tractor garaging with storage in the eaves.

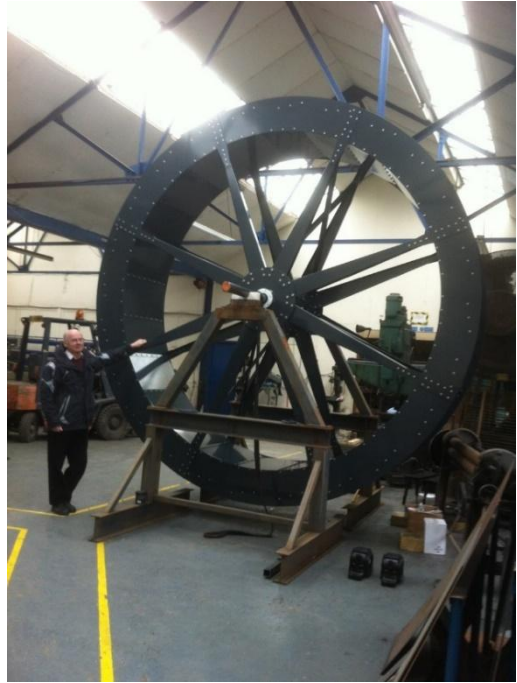
The new 3.8m steel waterwheel being constructed at the factory of Smith Engineering in Maryport, Cumbria, with Rod, the founder and managing director

By the time of our third visit, the wheel was installed and turning, although the electrical work and the construction of the launder was still to be completed.. The wheel is designed to generate 4Kw when turning at 6rpm.

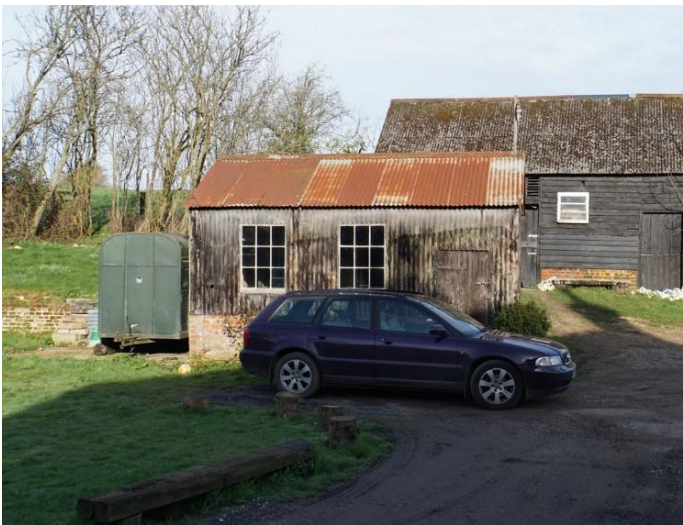
The tin shed which was appended to the mill and from 1891 to the 1920s powered the mill equipment via a steam engine and pulleys (due to the silting of the mill pond) before the mill finally fell into complete disuse in the late 1920s. This has since been relocated to elsewhere on the site. The weather-boarded building behind dates from 1837, and is a brick and timber oak frame barn for animals and feedstuff.

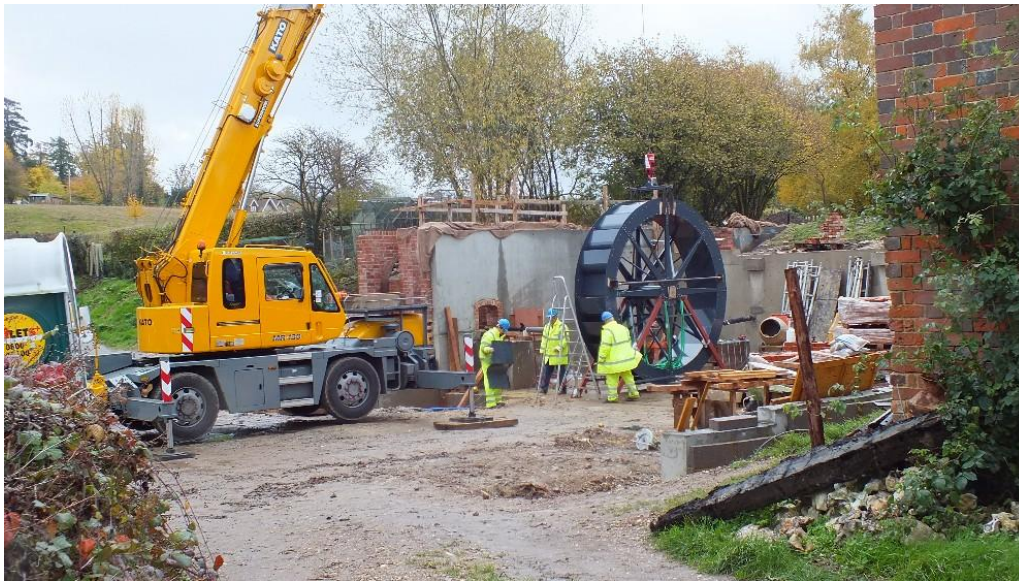
This picture was taken during the process of bolting together the two halves of the wheel; which had to be split to be transported from Cumbria.

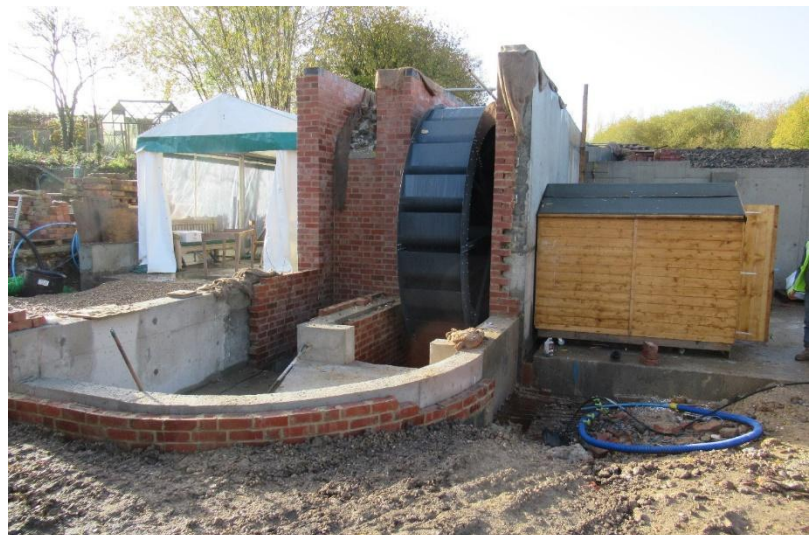
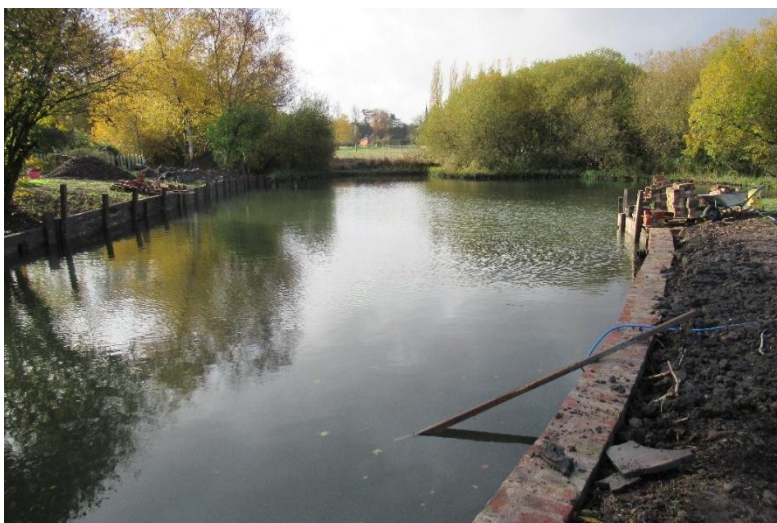
The wheel is now in its final position. A garden shed forms a temporary cover for the electrical kit, although when work is completed next year it will be inside the new building. The curved brickwork in the foreground is going to form an ornamental pond in front of the overspill waterfall. The tail race flows away underground in a tunnel, as it always did.
