Pilcot Mill Open Day

Pilcot Mill Waterwheel Axle

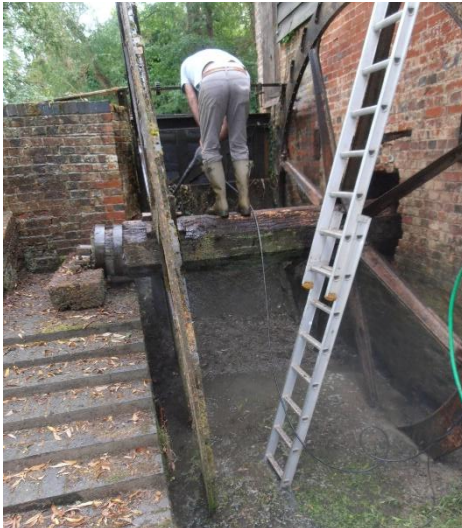
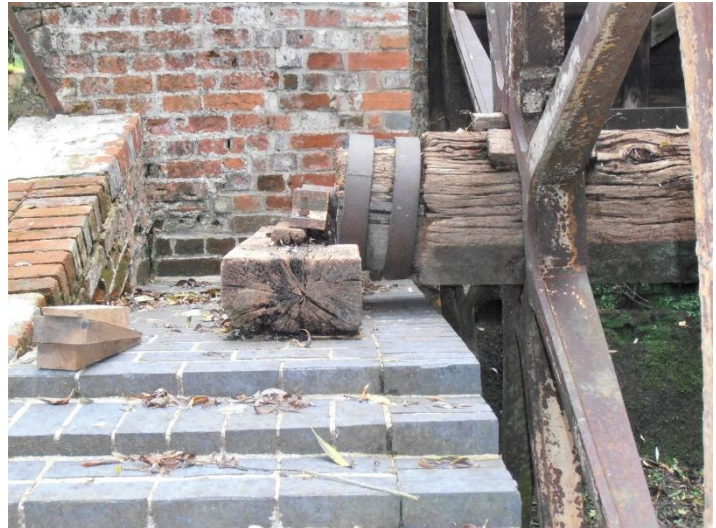
Back in July this year I prepared an inspection report on the mill of which the major item was the waterwheel and attendant construction. The waterwheel's oak axle has not been turned since it was last renewed, so the top area has been exposed to the elements all this time. The outer supporting gudgeon has suffered and started to become loose and the axle is subject to some decay over a large area.

During late October the waterwheel chamber silt was dug out and pumped dry with the generous help of a Dogmersfield neighbour. I have further investigated the degree of timber decay and cut out a large knot hole in the top surface, and drilled small deep test holes around the axle to determine where the axle should be cut off. A marked sketch was passed to John and Paul for advice. Recently the large knot hole and three test holes have received consolidating resin to ensure the core near the cut-off is sound.

Advice was taken on how to repair the axle, firstly from John Christmas and secondly from Paul Bracey (one of our newer members). Together we have slowly prepared an engineering solution to a millwrighting problem, as the most economical method of repair. Using Paul's professional knowledge we now have a scheme with drawings and calculations to support our proposed repair.

Still needing to be addressed are a decision on the fabrication of the corten steel metalwork and the practical aspects of how to safely support the old axle while repairs are progressed.
