Dogmersfield: Pilcot Mill on a tributary of the River Hart

OS REF 186 786 528

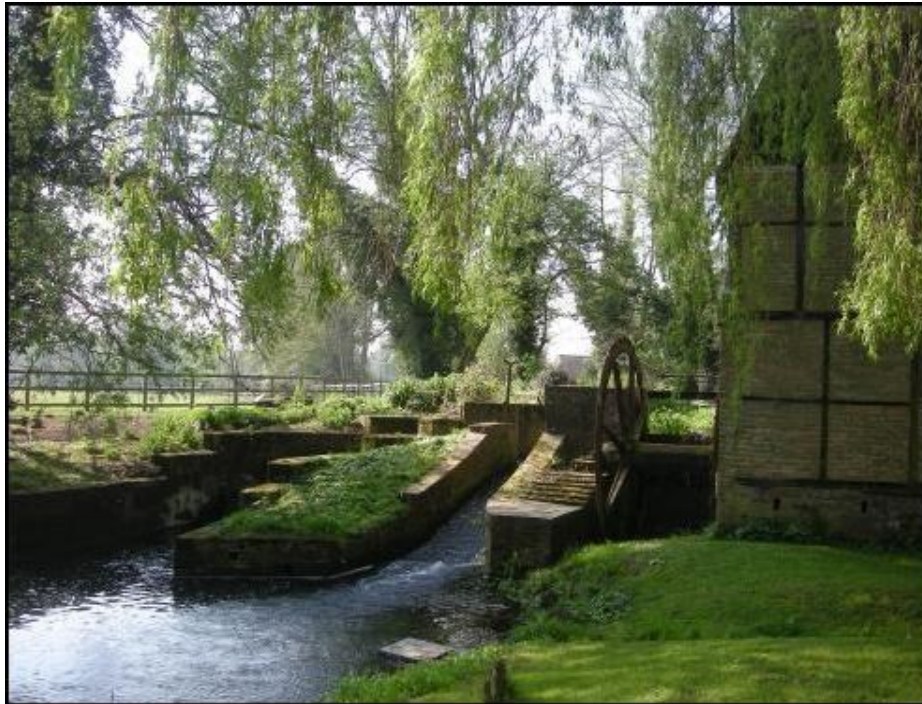
This small three storey mill is separate from the mill house. It is timber framed with brick infill and the upper storey is weatherboarded. The tiled roof is half hipped. The external iron Poncelet waterwheel is still in place but is deteriorating. Outside the mill at one end is the base of an engine. The stream which powered the wheel floods easily and has two bypass channels adjacent to the wheelpit. The pitwheel and all the machinery are still in the mill including two pairs of stones, one of which is a French Burr. The pulleys for an internal hoist as well as the grain bins and shuts are still intact. The mill and the mill house are listed buildings.

The mill is still in pretty good shape although some of the older timbers in the hurst frame and doors were becoming fragile. Geoffrey Finnigan had replaced the joists and floorboarding to the stones floor (1st floor) and the stones themselves were gathering moss (nowhere to roll to!). All the machinery was still in situ and ropes around the pulleys, which Geoffrey had renewed, were fine.

The massive oak wheel axle still looks healthy but the Poncelet waterwheel is now just represented by the two outer frames. Some previously salvaged rusting buckets and inners, found at the back of the 'Hampshire Hovel', had badly suffered from "rust beetle" and just two buckets were stored in the mill whilst all else was heaved into the skip.
